Vehicle Return Guidelines

IVECO
CERTIFIED PRE-OWNED

Content

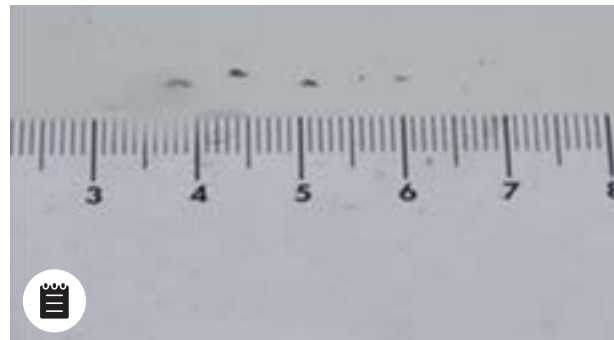
Chip ≤ 5 mm in diameter and ≤ 20 chips

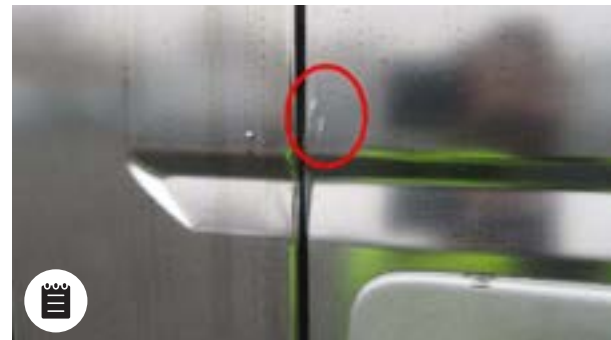
Chip on door edge

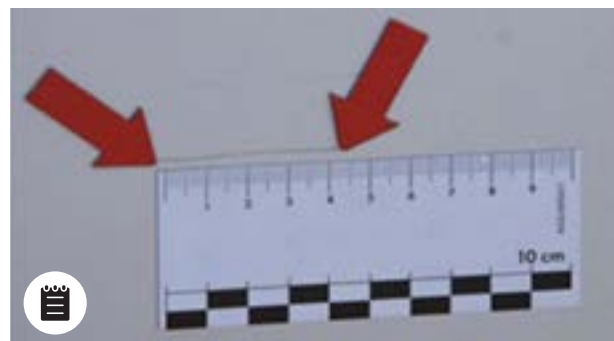
Polishable damage or scratch ≤ 50 mm

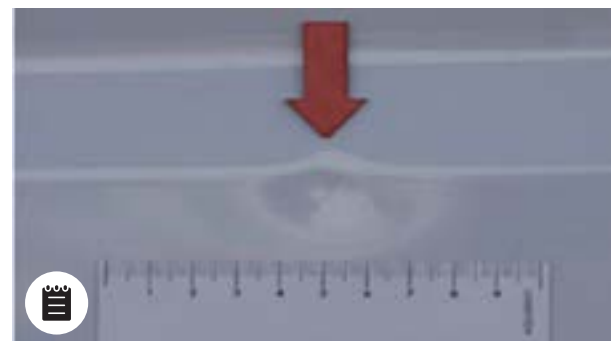
Indentations ≤ 50 mm in diameter with unaltered paint, no hail damage and significant pockmarks within in the limit of 5 indentations per panel

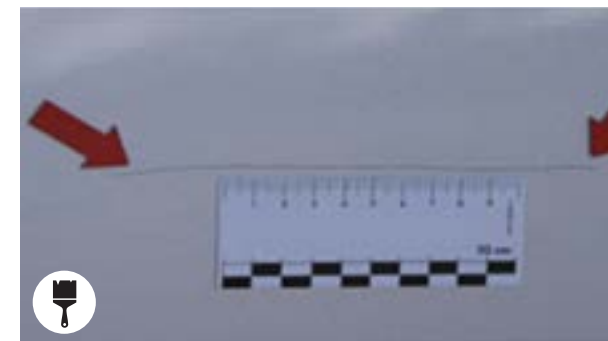
Scratches > 50 mm

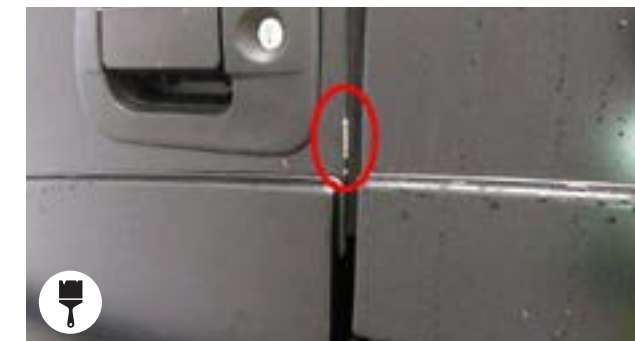
Chip on door edge

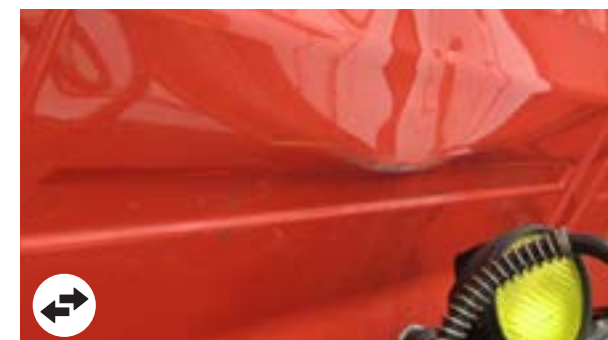
Irreparable parts, beyond economic repair or non-compliant exchanged part

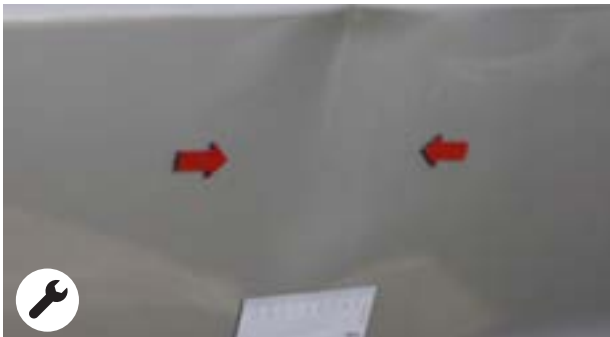
Indentations > 50 mm in diameter; altered paint, hail damage or significant pockmarks
NB: Smart repair possible on isolated, significant pockmarks if paint is not altered

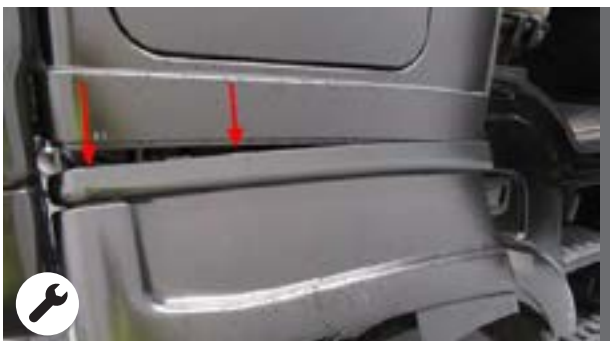
Difference in shade following repair
NB: Tolerance accepted linked to ageing of the vehicle

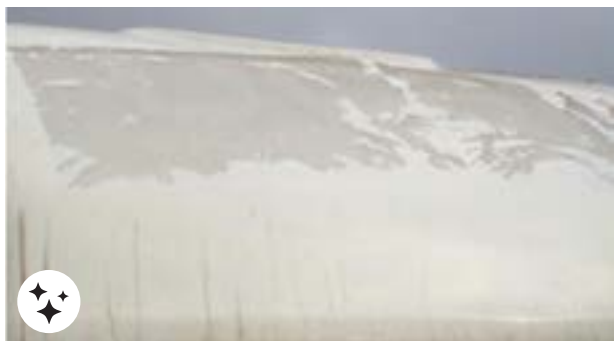
Trace of glue. NB: Presence of tags or graffiti, valuation in real time during cleaning and/or buffing (if not possible to clean, replace)

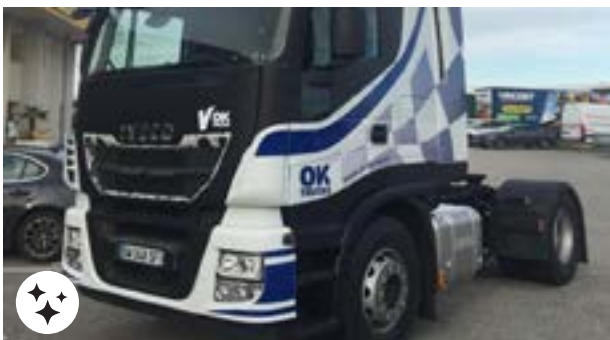
Marks left by advertisements following the description of the bodywork.

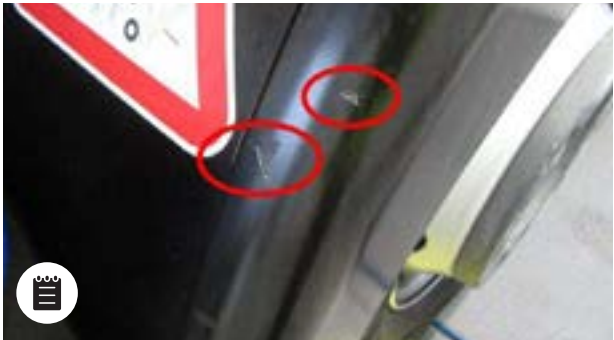
Scratches that cannot be felt with your nail and surface ≤ 45 cm² (equivalent to a credit card)

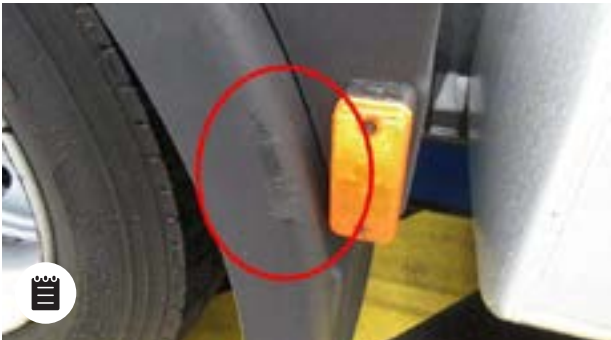
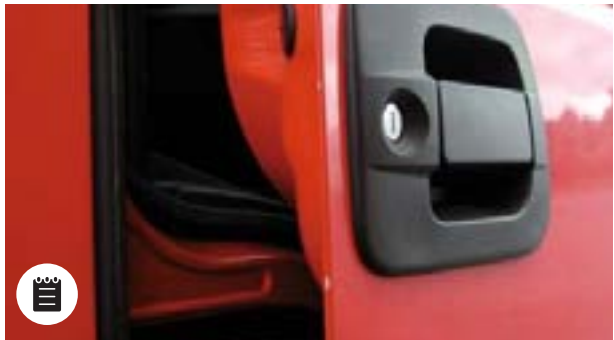
Faint superficial scratches, e.g at the fuel filler cap, hatches, door handles, bumpers and trims

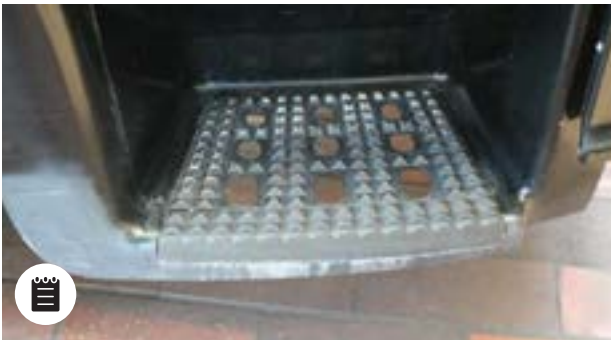
Faint scratches in the paint at the loading edges

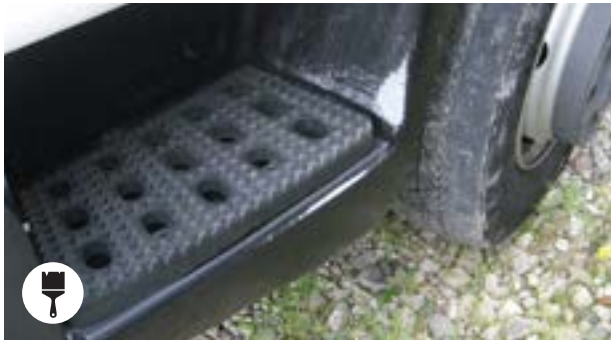
Scratches that can be felt with your nail or surface > 45 cm² (equivalent to a credit card)

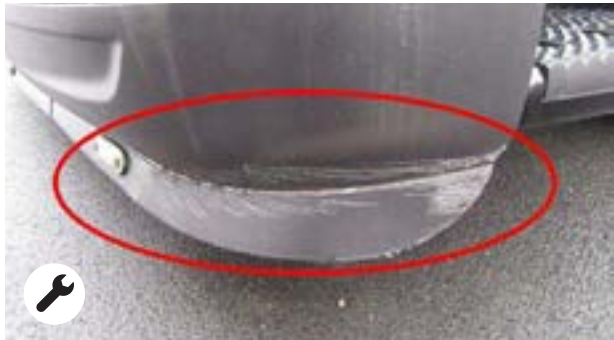
Removal of material or deformation feasible or economical to repair

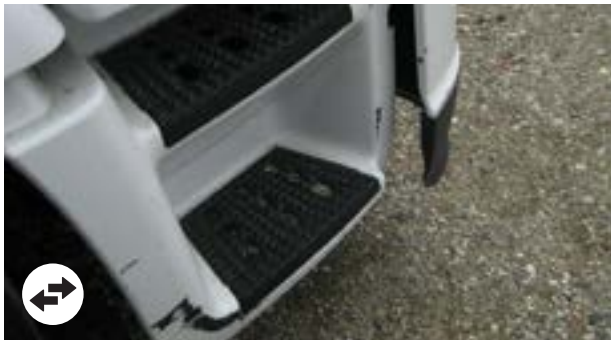
Removal of material, broken part

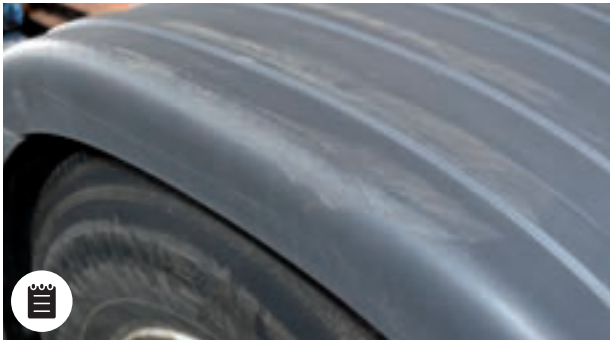
Slight surface scratching

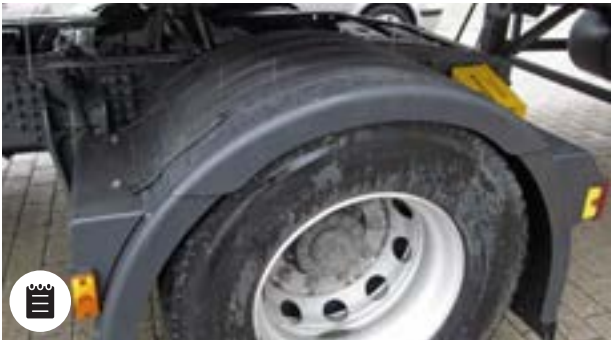
Slight deformation

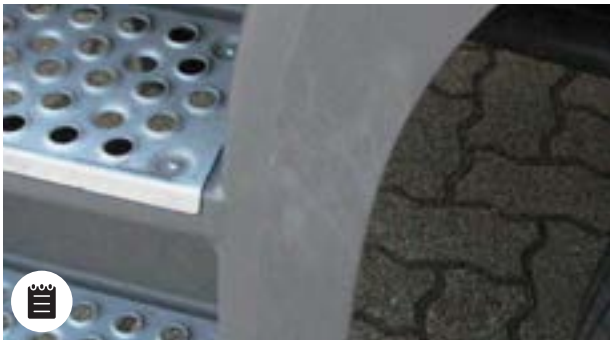
Slight discolouring

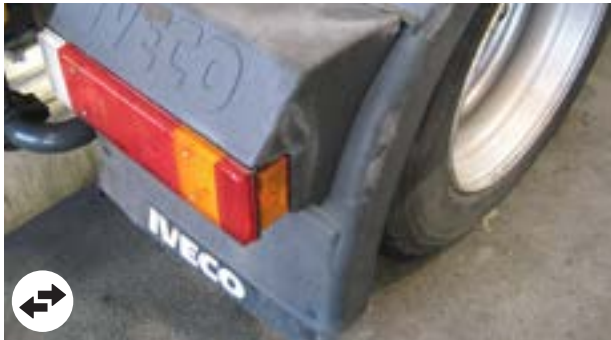
Deep scratches and deformation

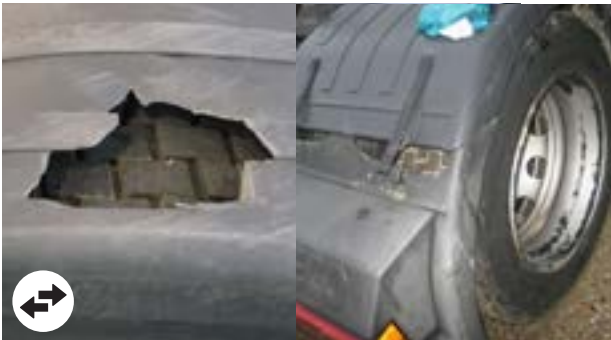
Removal of material, broken part

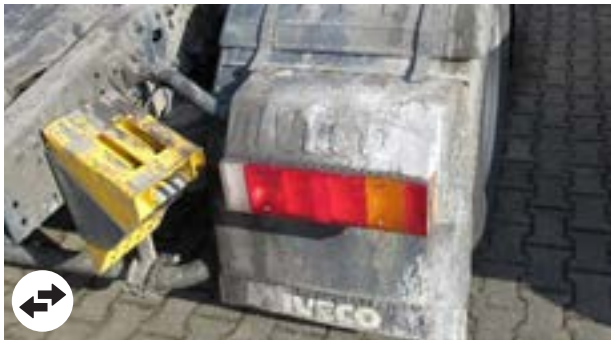
Deep discolouring due to chemical elements

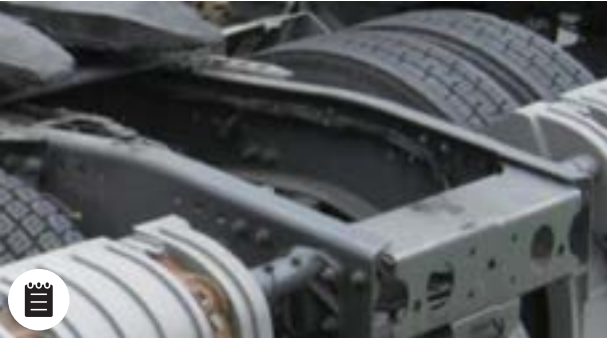
Slight paint scuffs around top frame, rear or crossmember

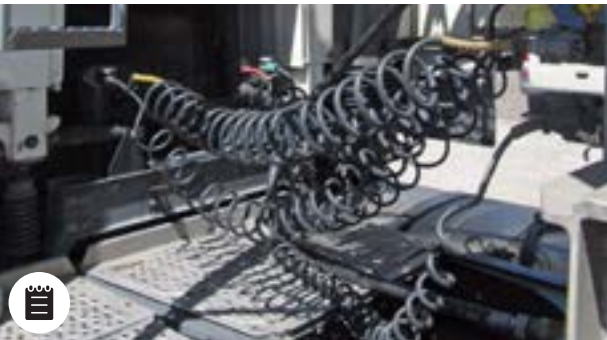
Surface scuffs around catwalk

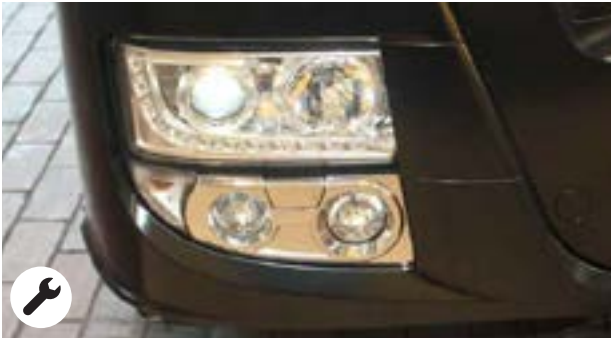
Faint scratch (without removal of material), outside of lighting field and sealed light (BUFFING)

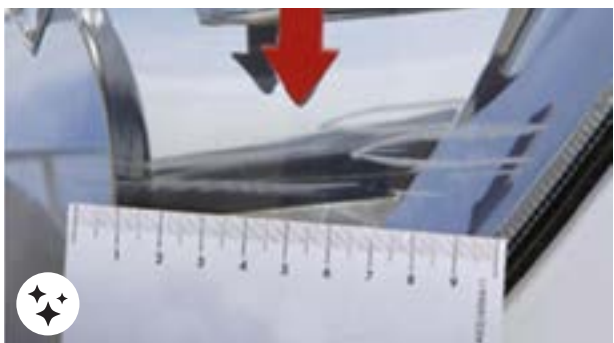
Deep scratch (with removal of material),
outside of lighting field and sealed light

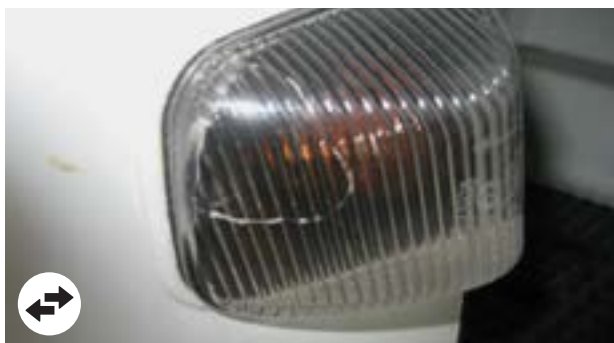
Rear and front lights broken

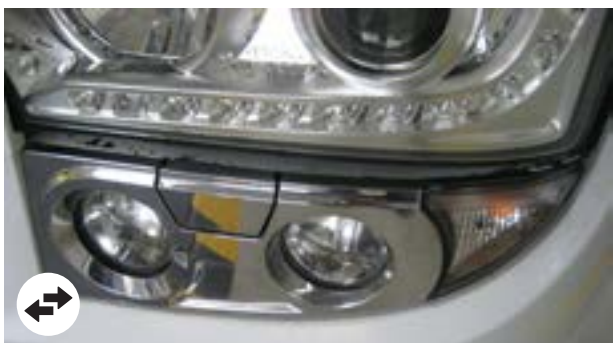
Scratch in the lighting field, crack, condensation, broken or broken fastening

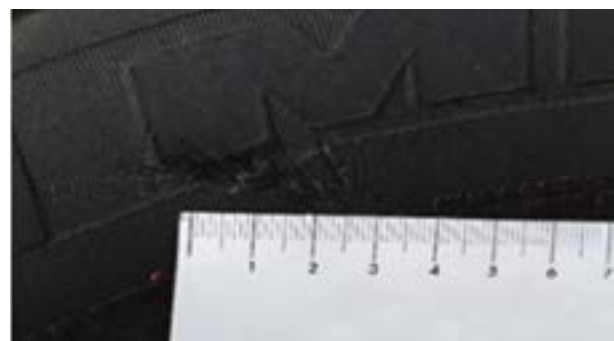
Tyres: Notch ≤ 3 mm deep (CONFORMS)

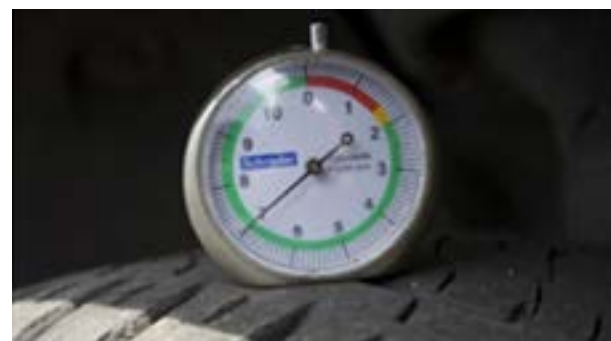
Tyres: Base of groove depth ≥ 7 mm (CONFORMS)
Note: The wear of the tyres is measured in the most worn groove on the tyre.

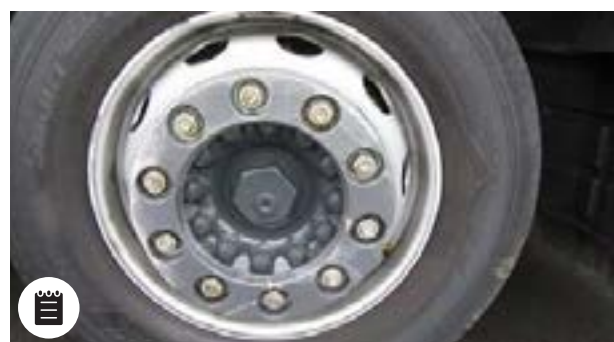
Rims and wheel covers: Multiple superficial scratches with or without removal of material

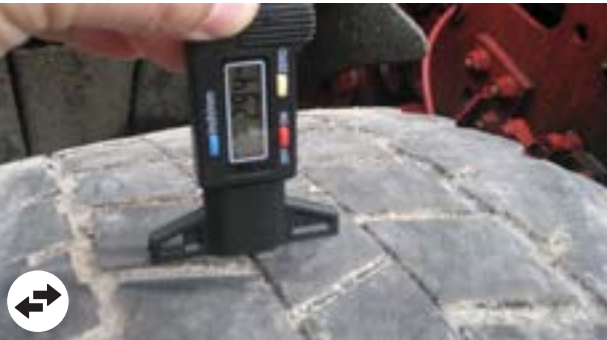
Tyres: Notch > 3 mm deep, removal

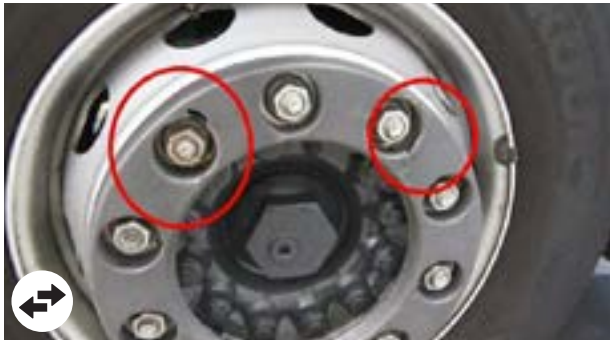
Wheel covers: Deformed, broken, material missing or removed

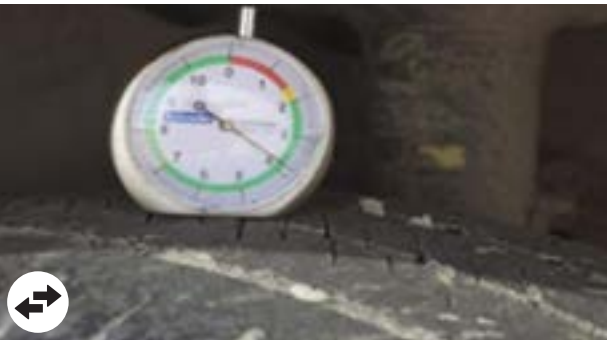
Tyres: Base of groove depth < 7 mm
Note: The wear of the tyres is measured in the most worn groove on the tyre.

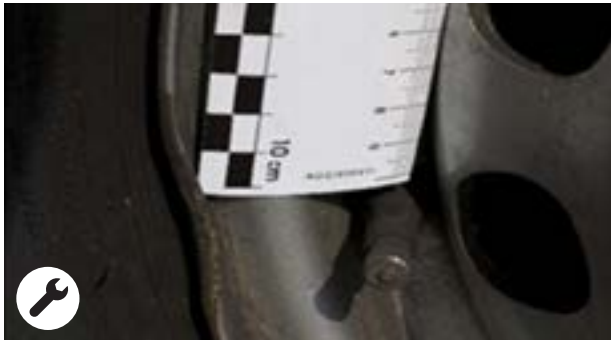
On steel rim: Attachment edge slightly deformed

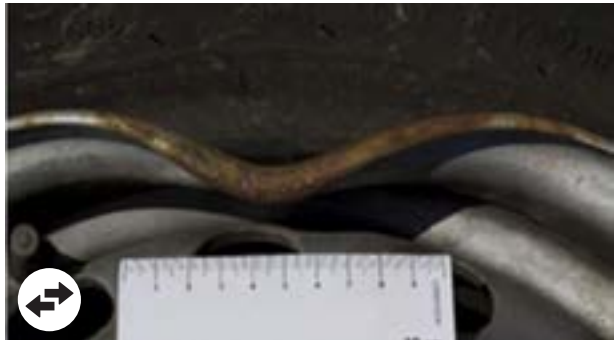
Rim lining damaged, non-compliant rim. Valuation of a dimensional check to check safe state of the vehicle

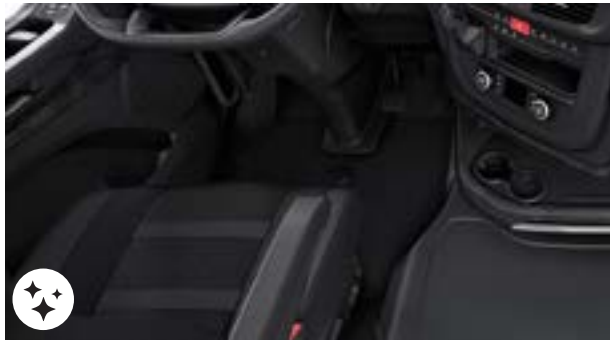
Light soiling can be removed by chemical cleaning carried out by a professional

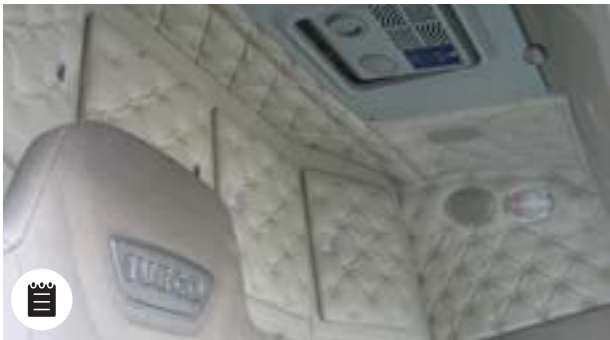
Slight decolouration due to sun rays

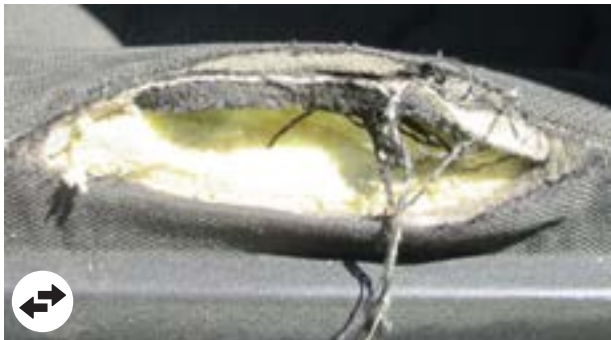
Foam missing or broken frame

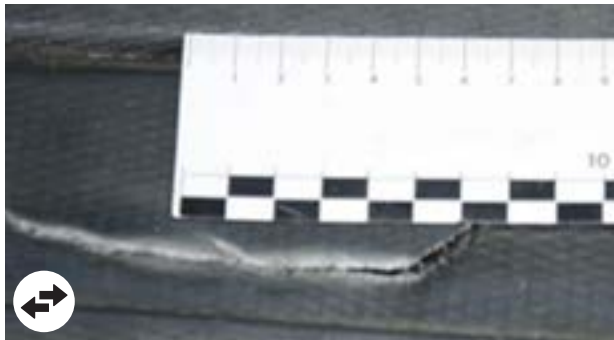
Perforation of hard plastic trims. Repair of hard plastic trims 1 hour flat rate if aesthetically acceptable and repairable

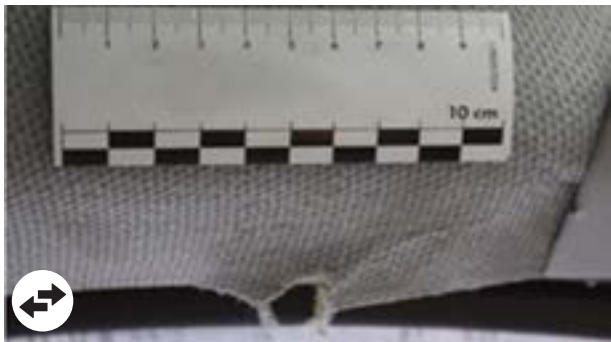
Fabric and plastic trim: Tear, hole > 5 mm, indelible marks

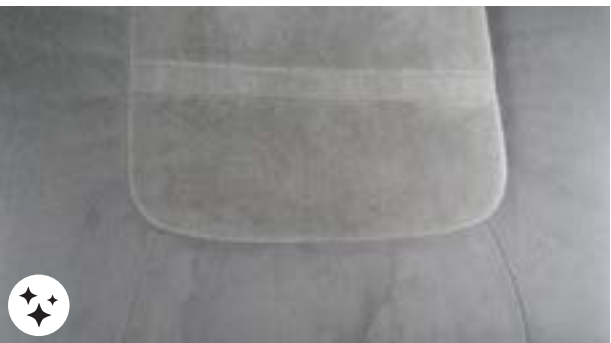
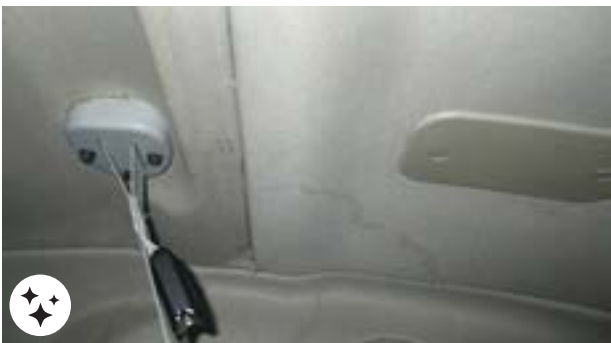
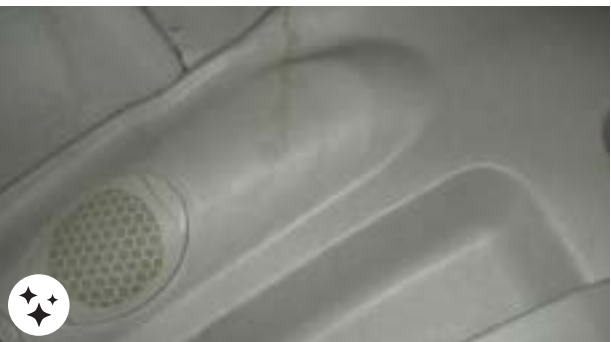
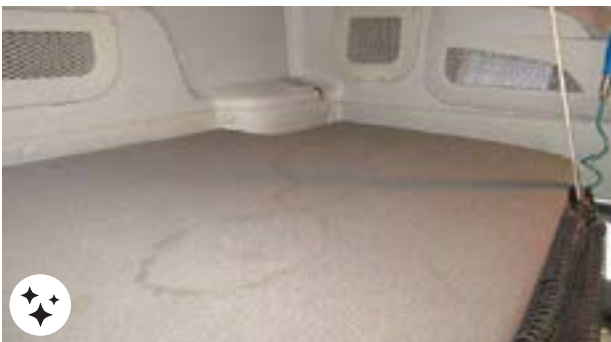
Significant soiling, stains and smells requiring chemical cleaning carried out by a professional.

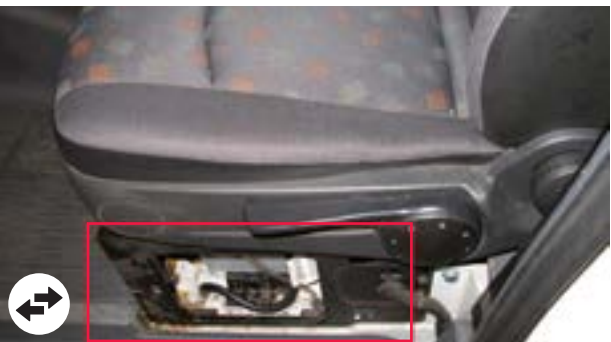
Missing equipment or trims

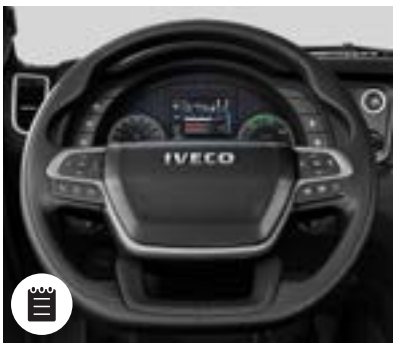
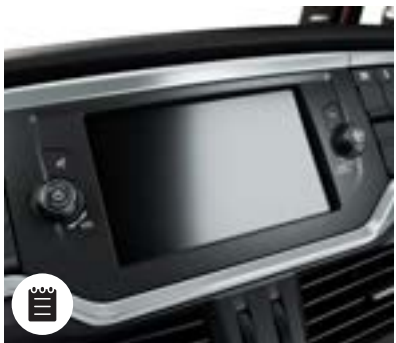
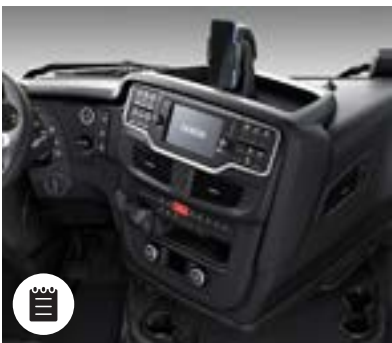
Traces of wear on the instrument panel, instrument cluster and steering wheel

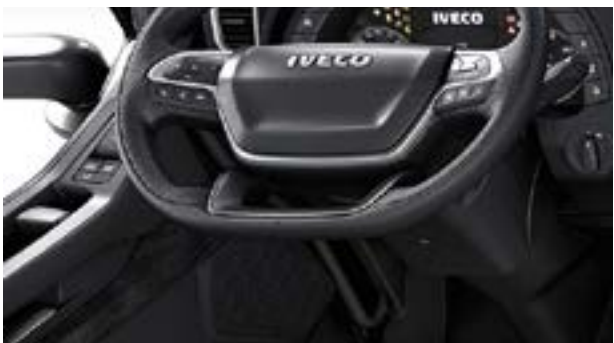
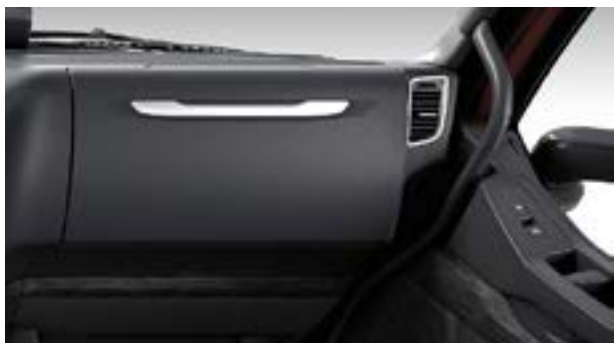
- Slight discolouration due to sun rays
- Light soiling can be removed by chemical cleaning carried out by a professional

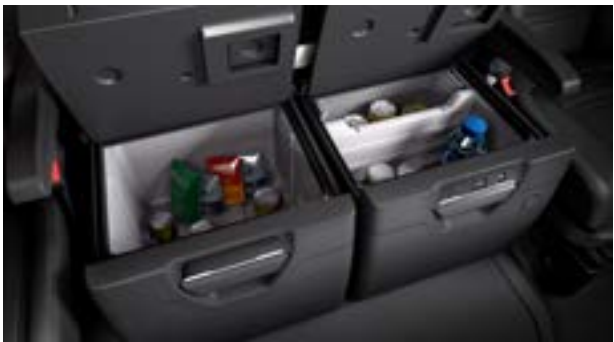
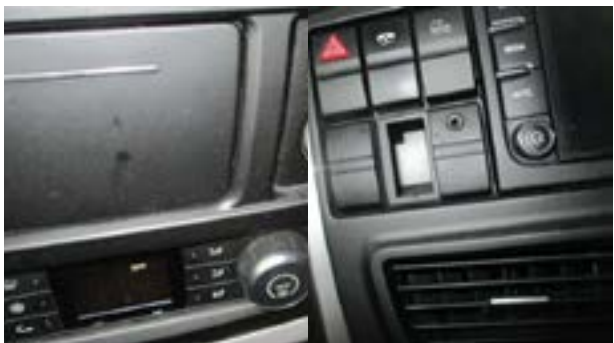
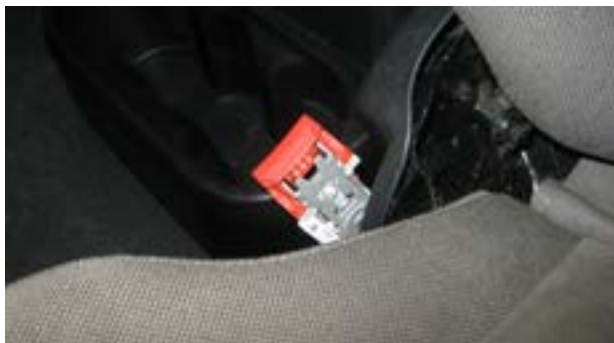
- Control parts, seat or trim parts missing, broken or pierced
- Systems, seatbelt, seat control, displays and visuals not operating

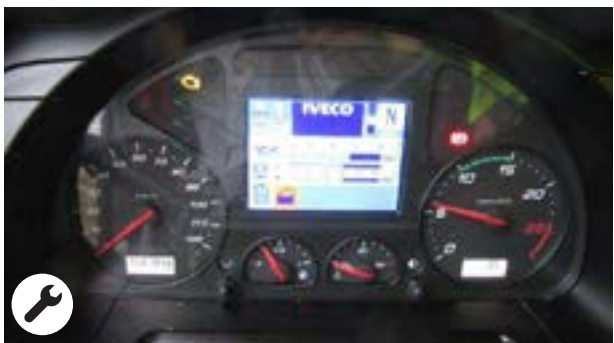
Scratches on the combined instrument panel and other visuals or holes in the field of vision

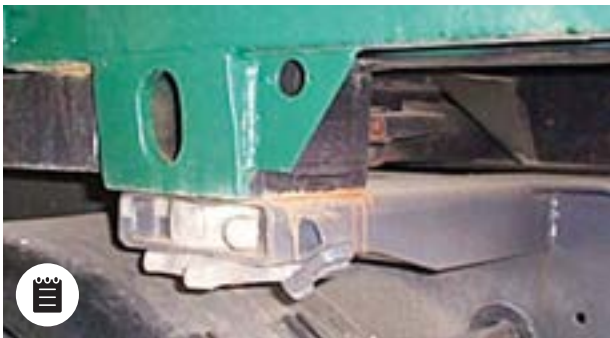
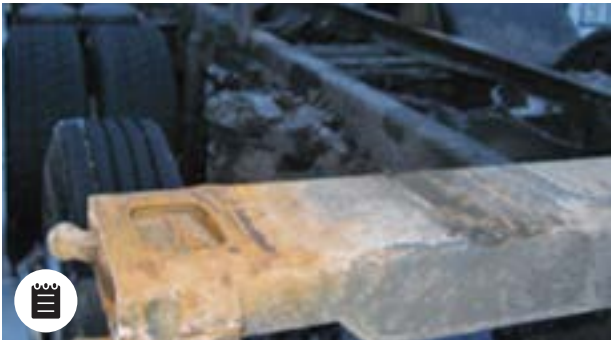
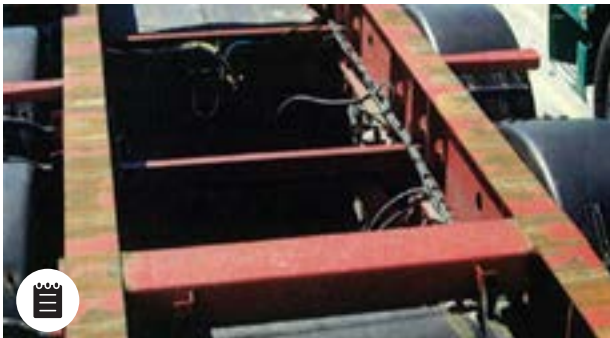
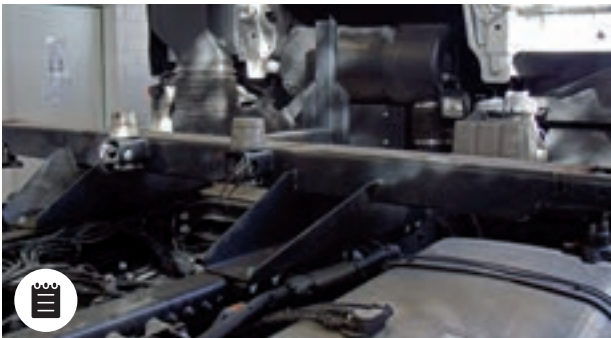
Signs of wear typical of the expected use

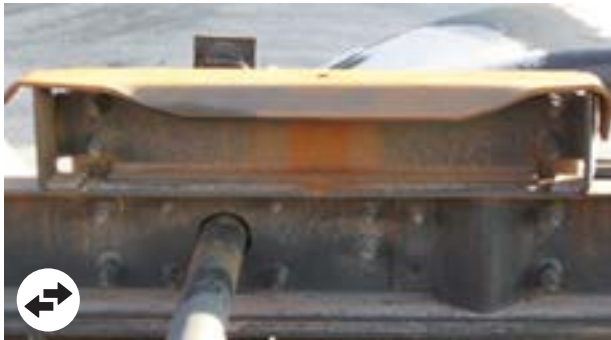
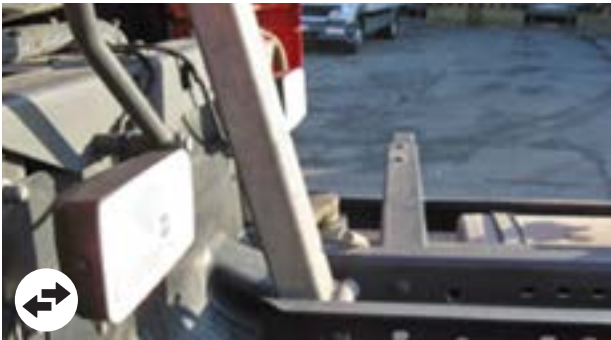
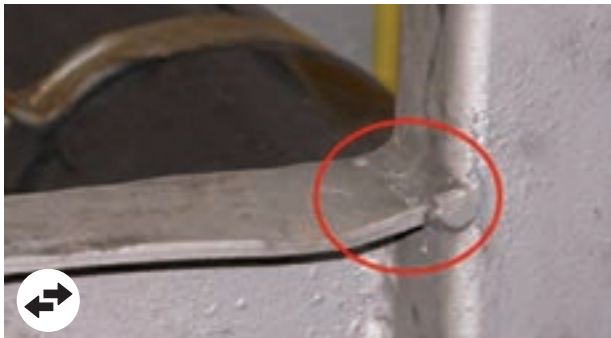
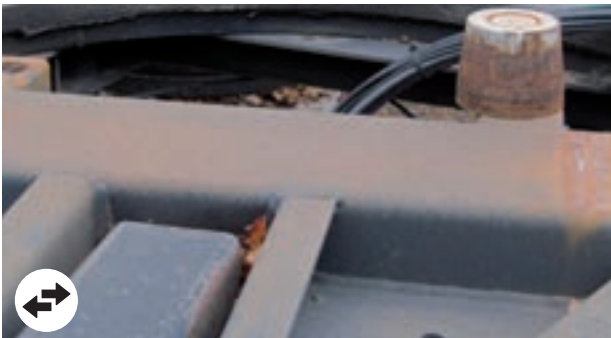
Breaks and deformations
Serious deformed and broken end stops
Broken twistlocks

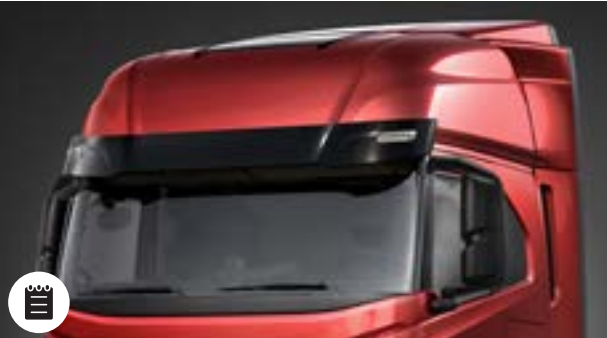
Cabover and deflector: Faint scratch in keeping with the vehicle appearance

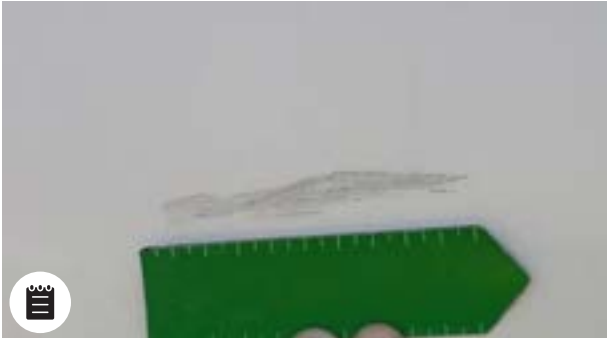
Side panels: Faint scratch with material removal ≤ 20 cm

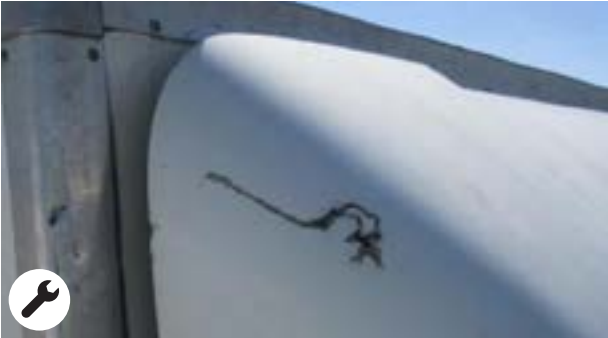
Cabover and deflector: Within economic repair

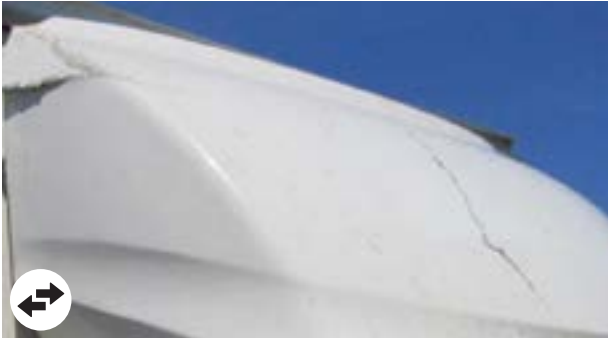
Cabover and deflector: Significant crack, missing part or beyond economic repair

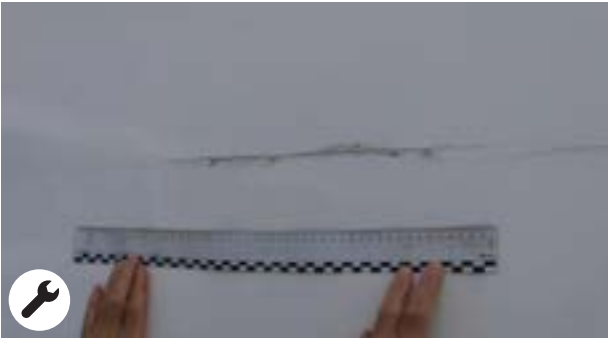
Side panels: Scratch with removal of material ≥ 20cm within economic repair. Option to paint half panel

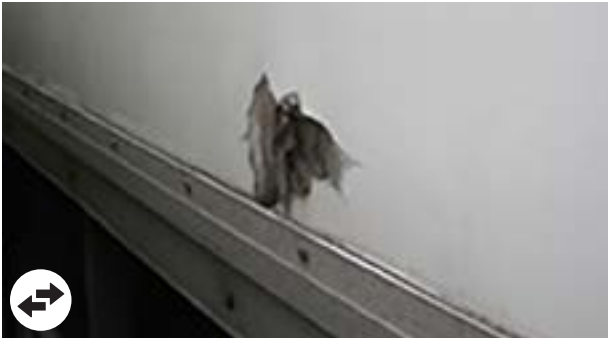
Wood side panels: Damaged wood support ≥ 20 cm

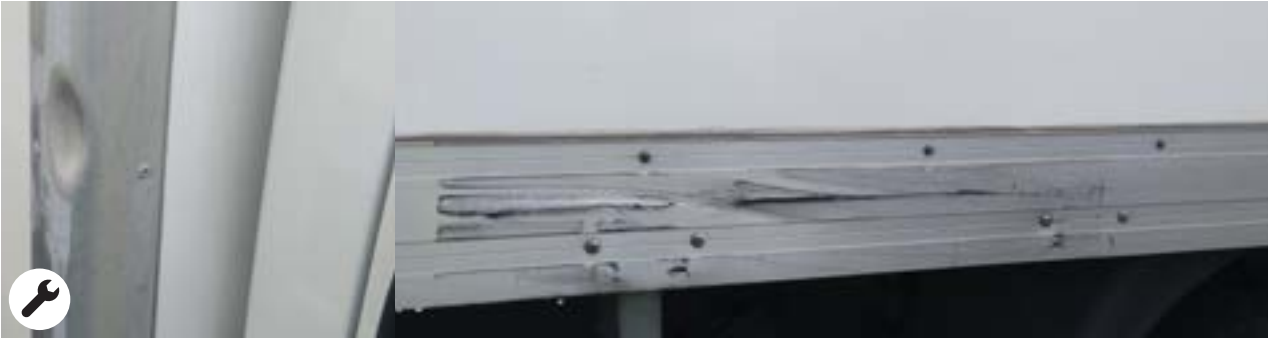
Underbody side profiles: Deformations within economic repair

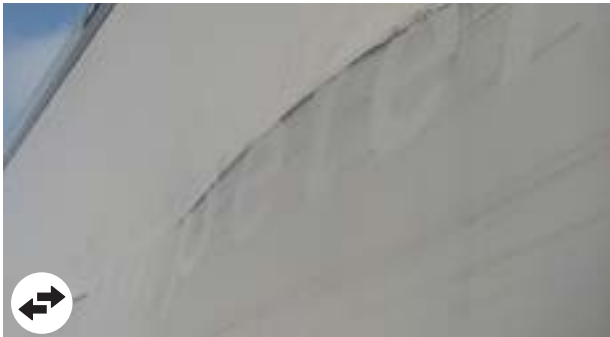
Fibre side panels: Deformation on lower part, length of > 1 m
NB: Replacement of the front panel of the underbody requires removal of the underbody.

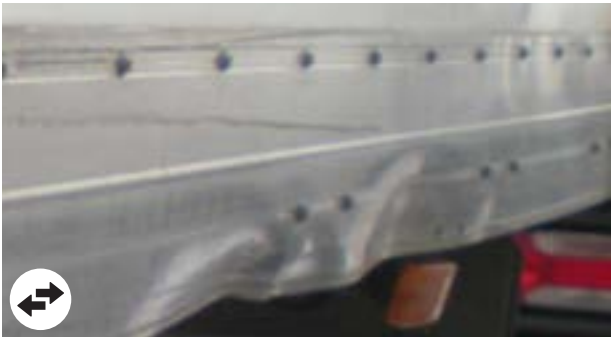
Underbody side profiles: Deformations beyond economic repair; perforations, removal of a section of the profile

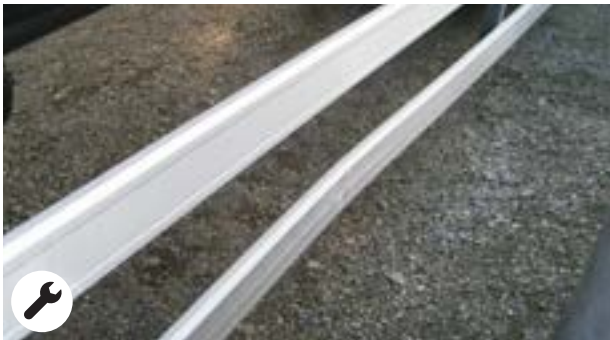
Bike racks: Deformation within economic repair

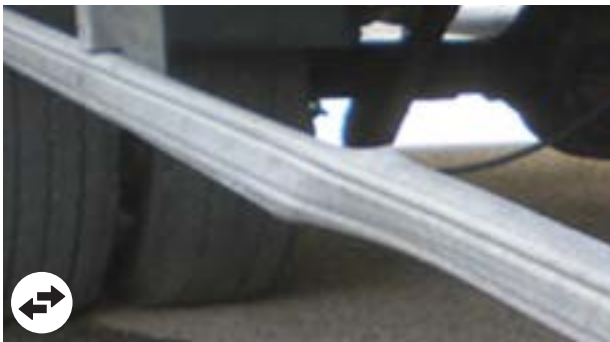
Bike racks: Deformation beyond economic repair

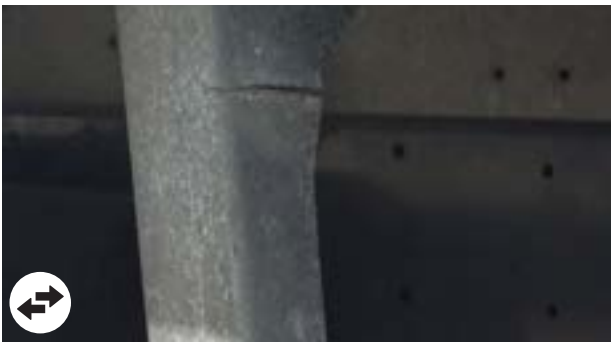
Tail lift: Deformations of platform beyond economic repair

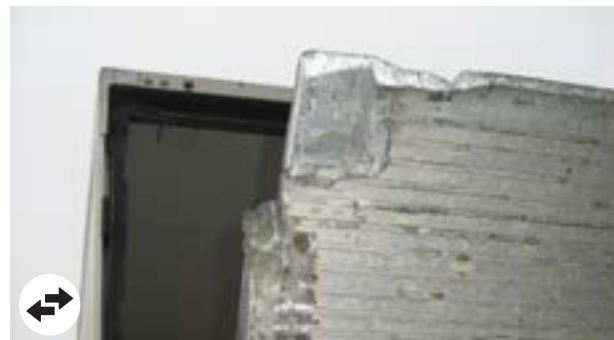
Tail lift: Deformations of platform beyond economic repair, broken or incomplete trim

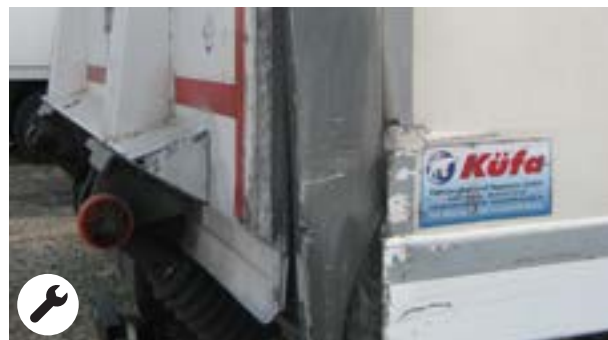
Side and rear doors: Significant deformation: Repair time > 1 h within economic repair, closure not sealed

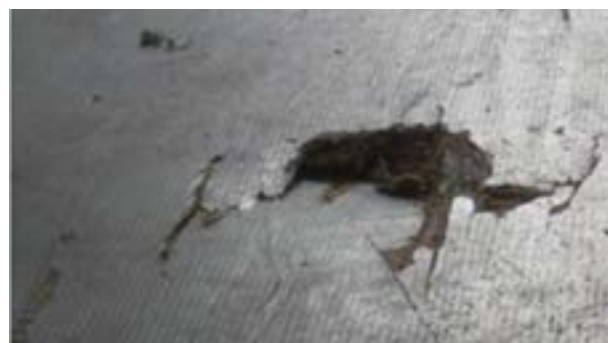
Side and rear doors: Doors bent at fastening points for hinges, broken, perforated, or beyond economic repair

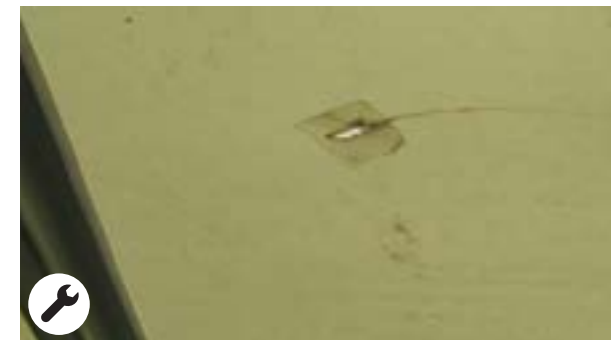
Flooring: Deformations or perforations within economic repair

Deformations or perforations beyond economic repair: Option to exchange flooring by section

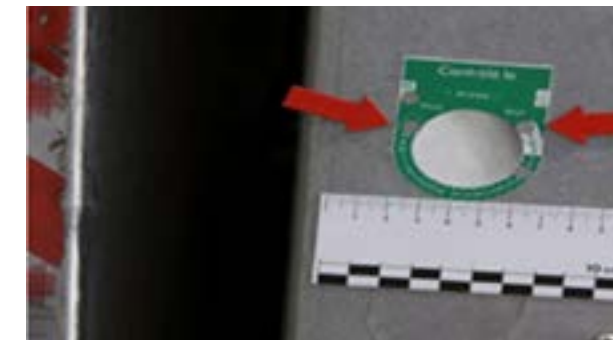
Roof space: Perforated or torn within economic repair

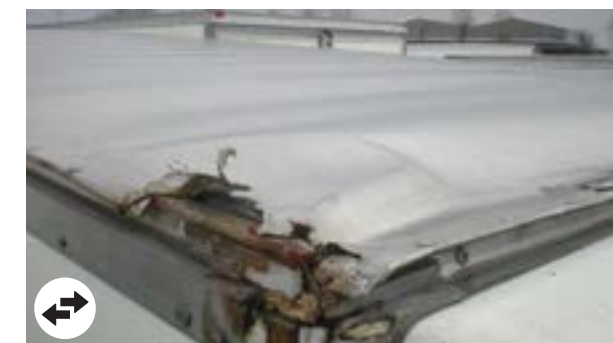
Roof space: Frame damaged, leather not within economic repair

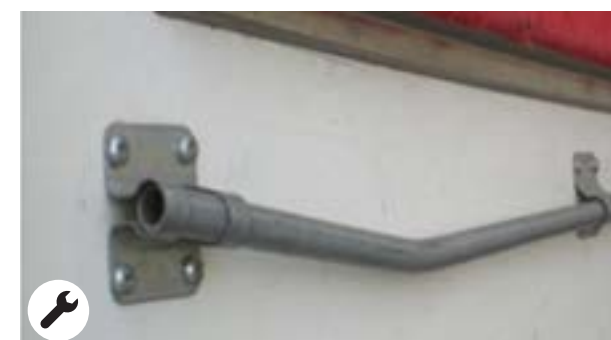
Upholstery and rods: Rods, fastenings, upholstery missing or deformed beyond economic repair

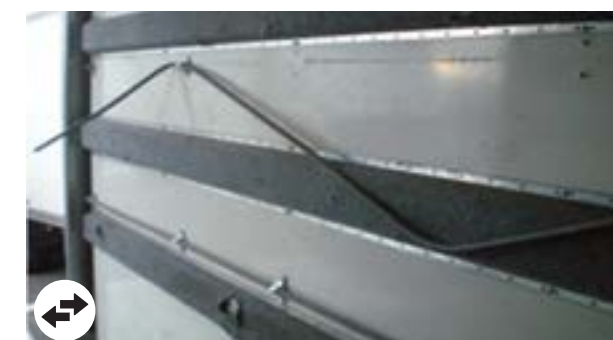
Upholstery and rods: Rods and upholstery deformed within economic repair

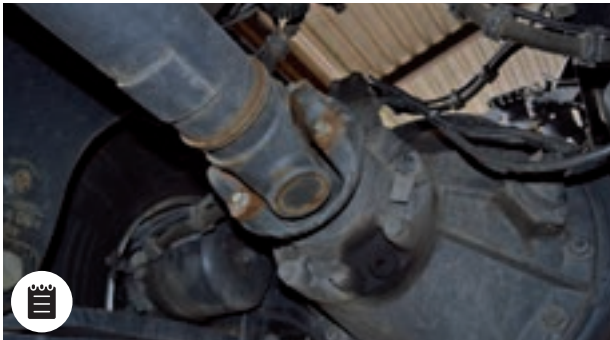
Signs of wear that do not impair road safety

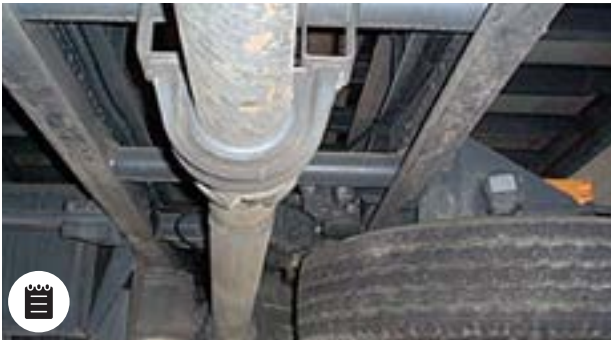
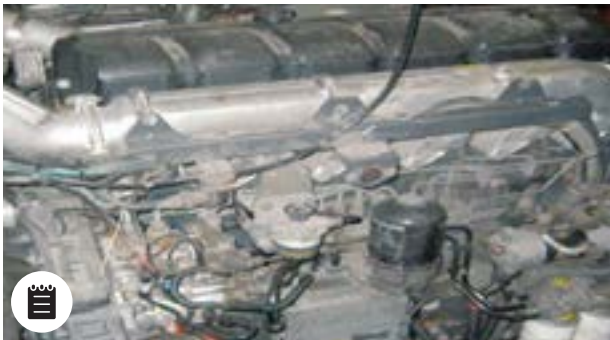
Light traces of oil (no dripping)

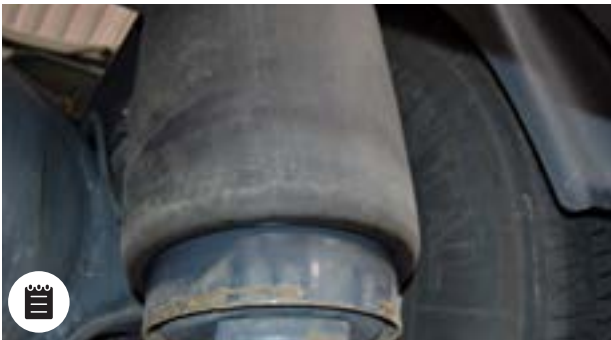
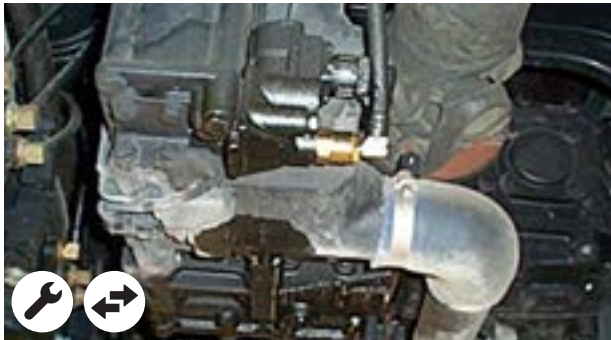
All leaks from the engine, gearbox and differential, hydraulic suspension and dampers

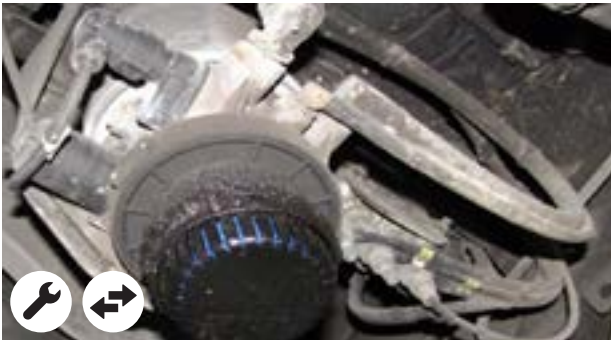
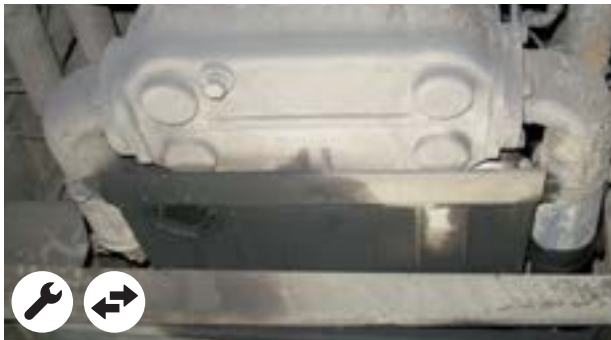
Leaks from the steering gear and power steering pump

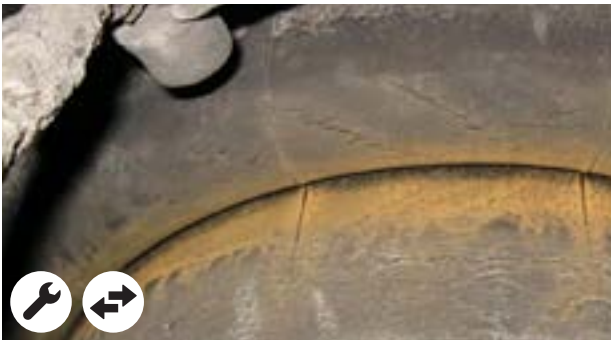
Others:

- Cracks in suspension bellows and transmission shaft bellows
- Broken springs
- All signs of wear that can be detected via a visual check and do not impair road safety
- Parts for axles, suspension and chassis that are damaged by shocks
- Worn track rods/transverse arms etc.
- Strange noises from the engine, gearbox, differential and drive chain

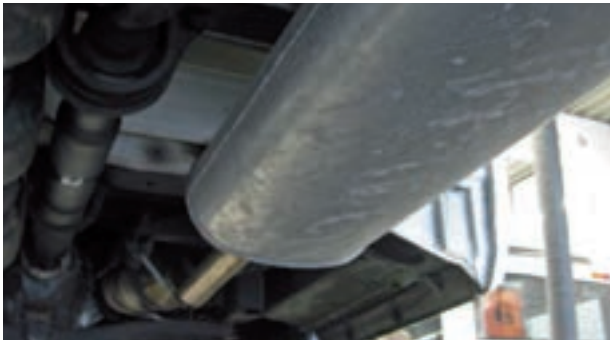
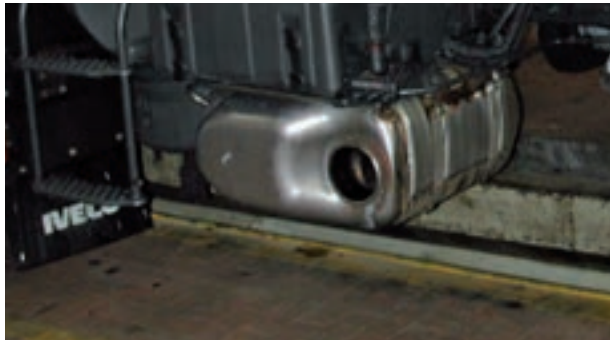
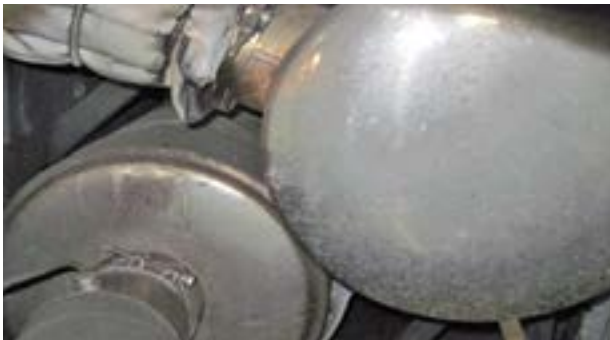
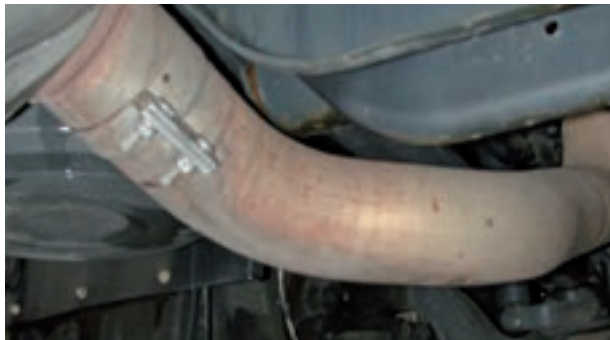
Condition conforms to technical inspection

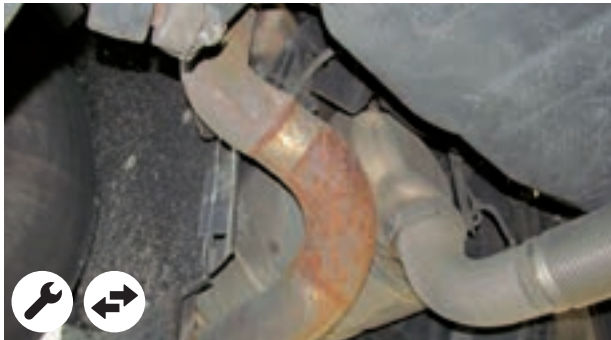
Presence of leaks
Rust

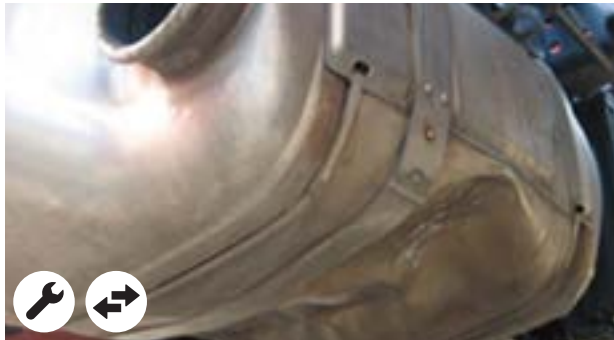
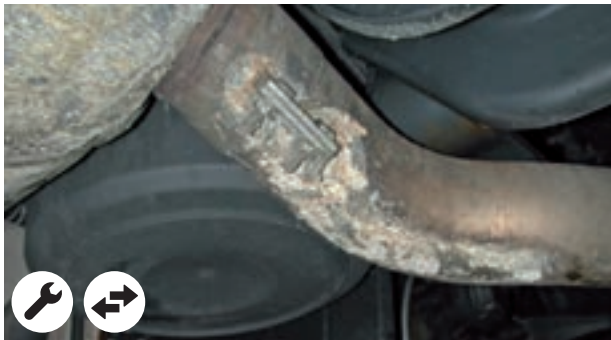
Damage due to external shocks
Missing equipment, e.g. exhaust outlets torn or deformed

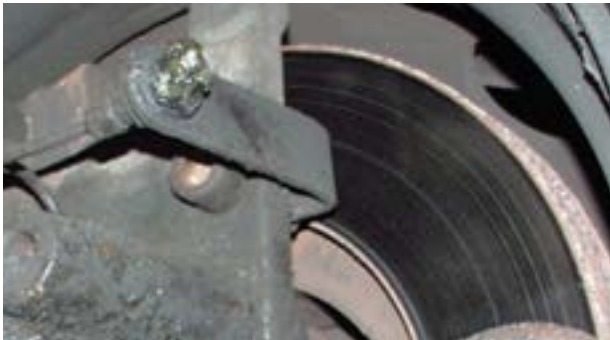
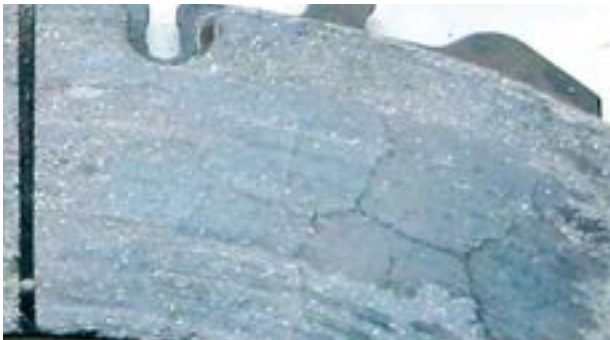
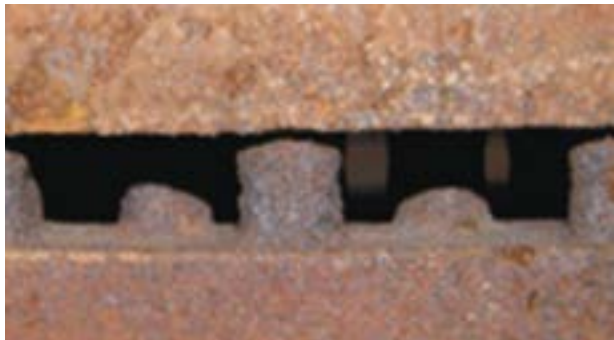
Brake System

Normal condition and conforms to the age and mileage of the vehicle
Brake pads thickness > 30 %
