Vehicle Return Guidelines

IVECO
CERTIFIED PRE-OWNED

Content

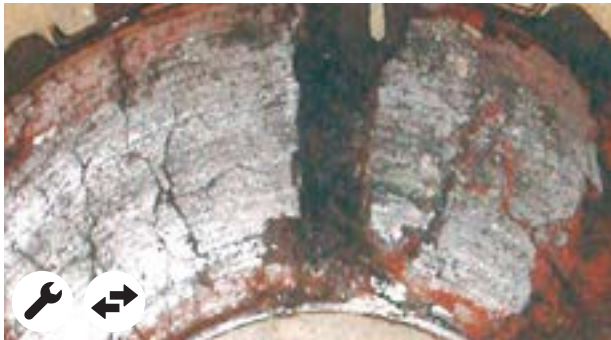
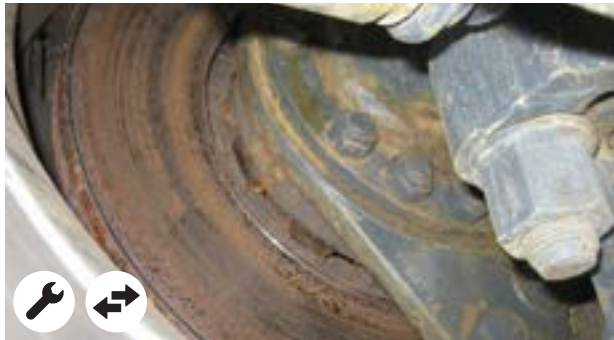
Rusted, ground, worn brake discs

Does not conform to highway code and not valid during technical check

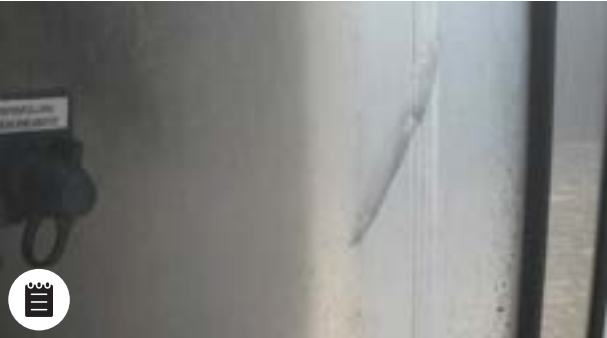
Fuel Tank

Minor fuel tank scratches

Very slight, no more than a 10mm in diameter, deformation of fuel tank without sharp edges which do not threaten leaks and proper operation of the tank

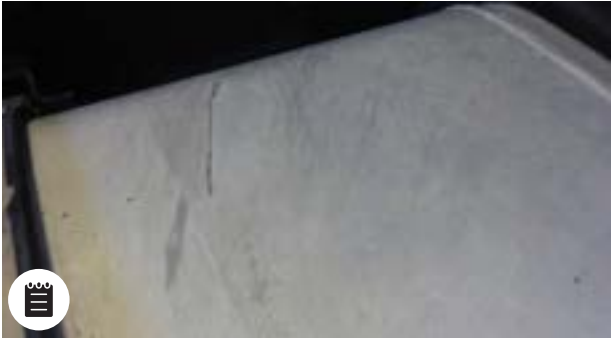
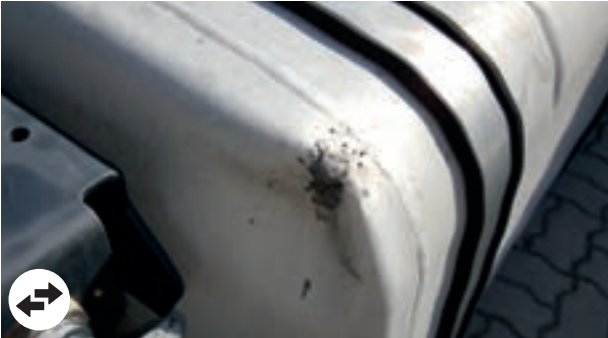
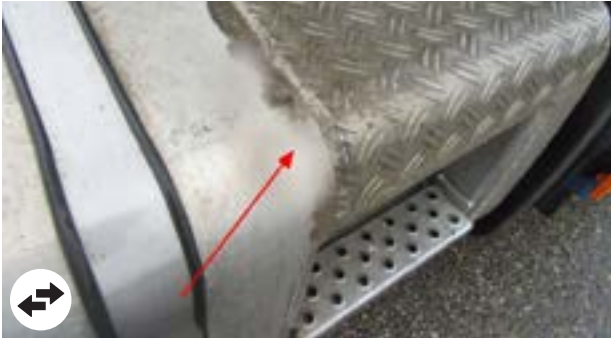
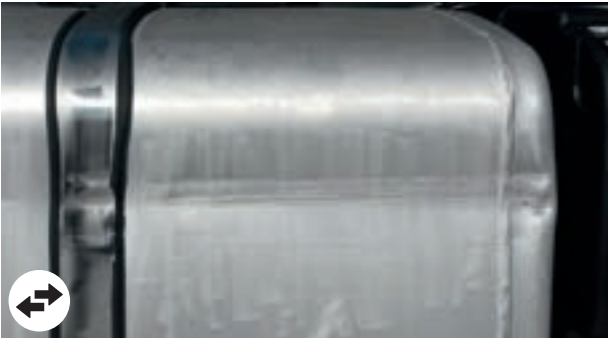
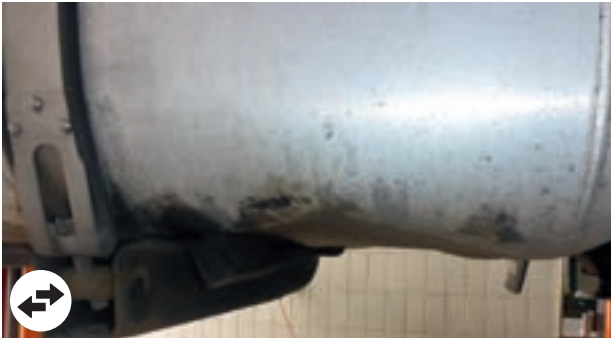
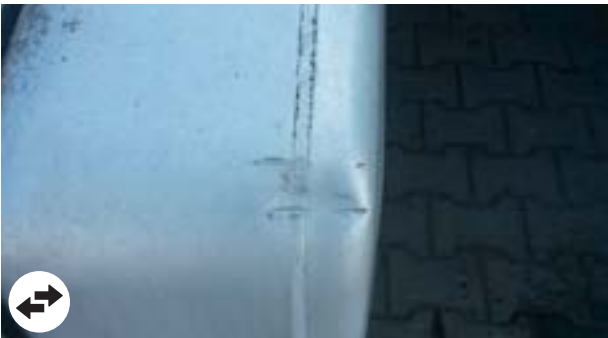
Fuel tank deformation which can threaten leaks, proper operation and reduce capacity of the fuel tank

Any welded repairs and or patches are not acceptable

Damage to fuel tank mountings is not acceptable

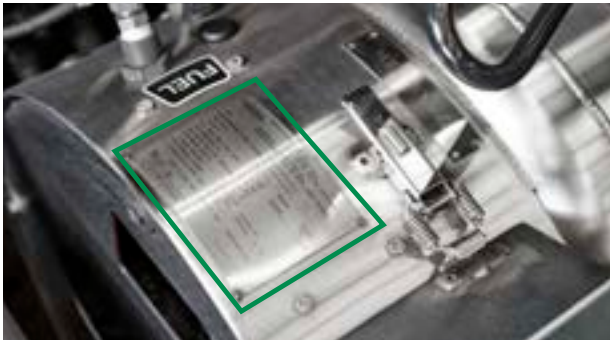
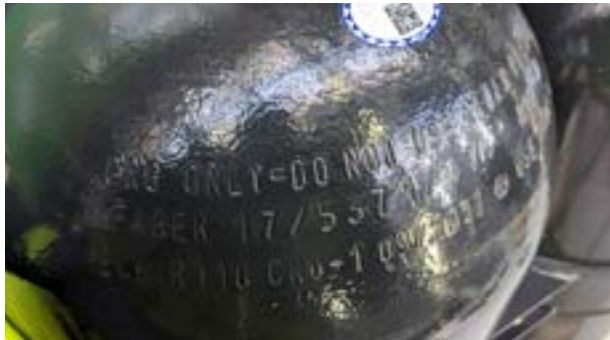
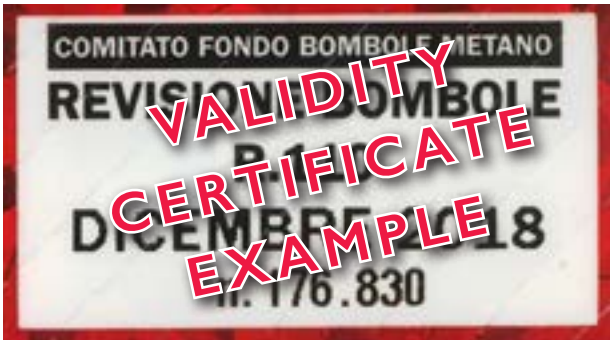
Administrative and Markings

Presence of an up-to-date validity certificate legible for LNG tank and CNG cylinder.

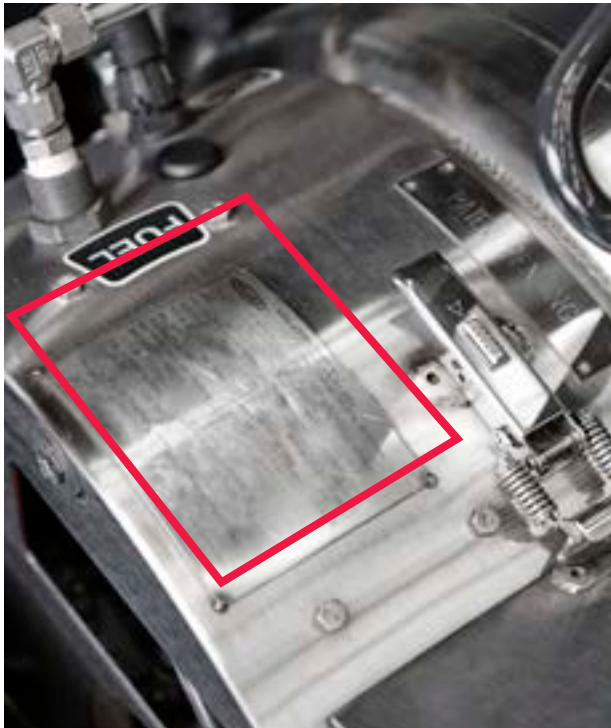
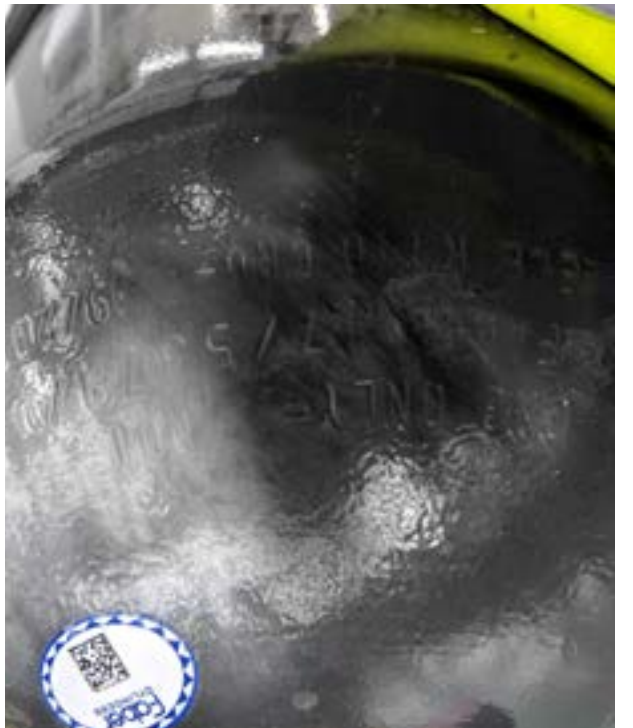
Original LNG tank and CNG cylinder identification markings absent or illegible
 → charge for replacement of CNG/LNG tank with a new one.

Absence of an up-to-date validity certificate for the tanks → gas certificate fixed charge of € 1500 before tax.

Note: For the LNG tanks, no European-wide procedure currently has been defined for the periodic requalification after 10 years. The date of validity on the original identification markings must be checked.

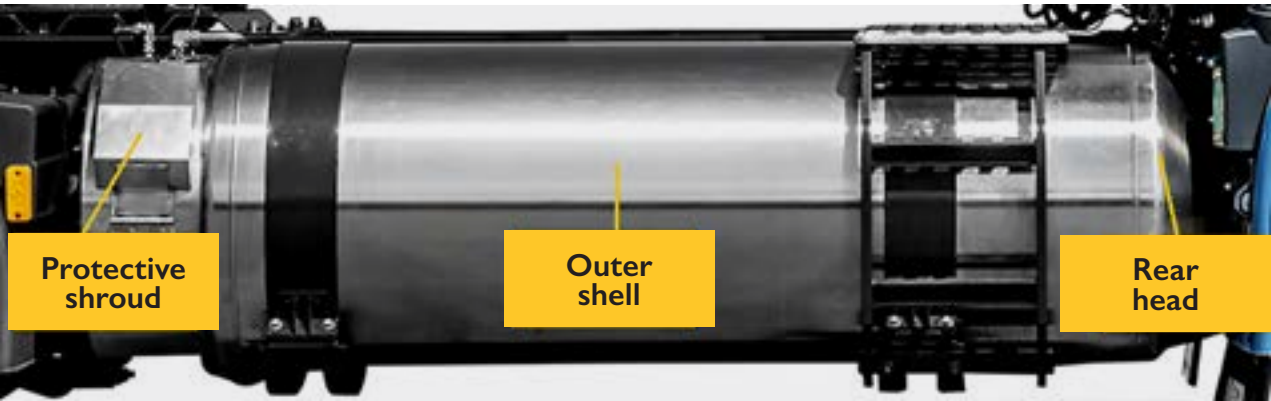
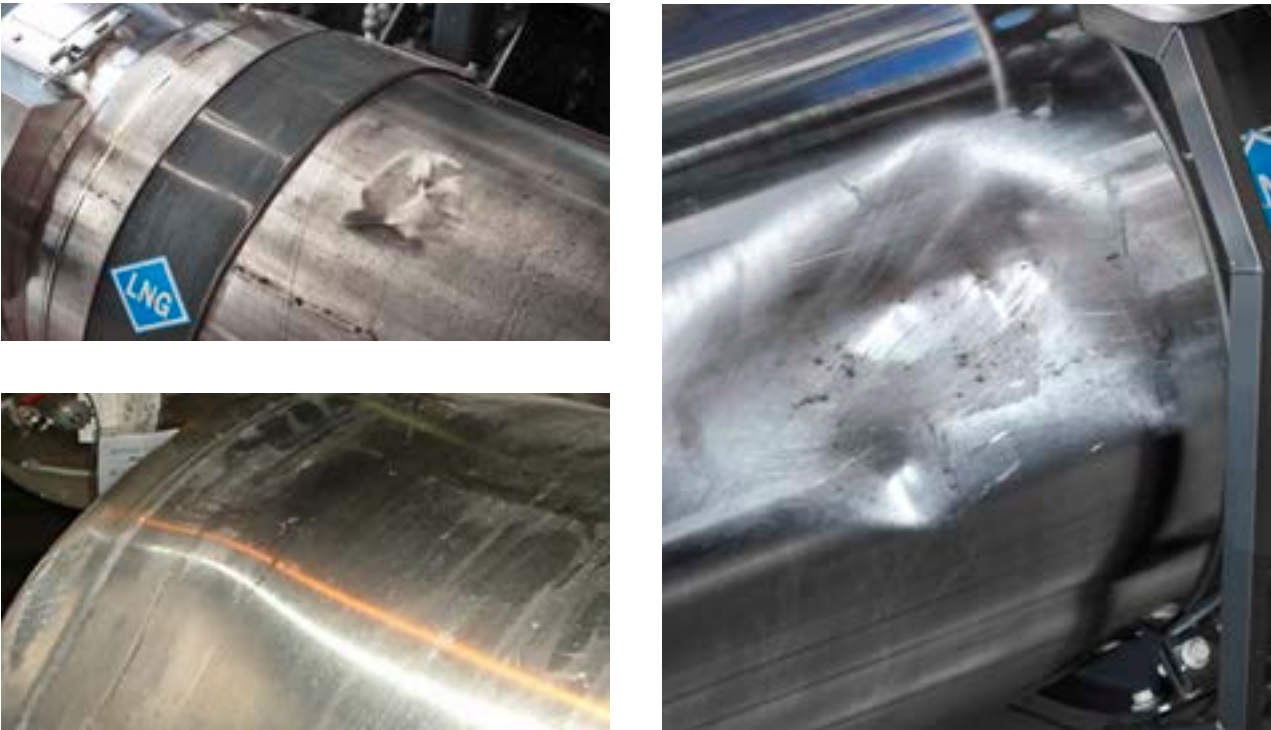
Evidence of tank repairs → charge for tank replacement.

Tank holed → charge for tank replacement.

Dent in outer shell:
Maximum depth of deformation ≤ 7 mm with no signs of frost or sweating
→ note without charge for damage (note in the expert report).
Depth of deformation > 7 mm → charge for tank replacement.

Dents on the rear head or on the protective shroud → charge for tank replacement.

Surfaces scratches in outer shell → note without charge for damage.

Any visual ice or frost spot on the outer shell or heads (excluding knuckle and its mounted plumbing)
→ charge for tank replacement.

Dents, cracks, splits or visible leaks at the weld seams or on welded components → charge for tank replacement.

Any cracks, splits or visible leaks on the outer shell, rear head or protective shroud → charge for tank replacement.

Damage to the fill receptacle or VENT valve → charge for replacement of components.

Inspect the pump-out port or cap for signs of damage or tampering. Half round cap must be intact and secured to the tank. If not present → charge for tank replacement.

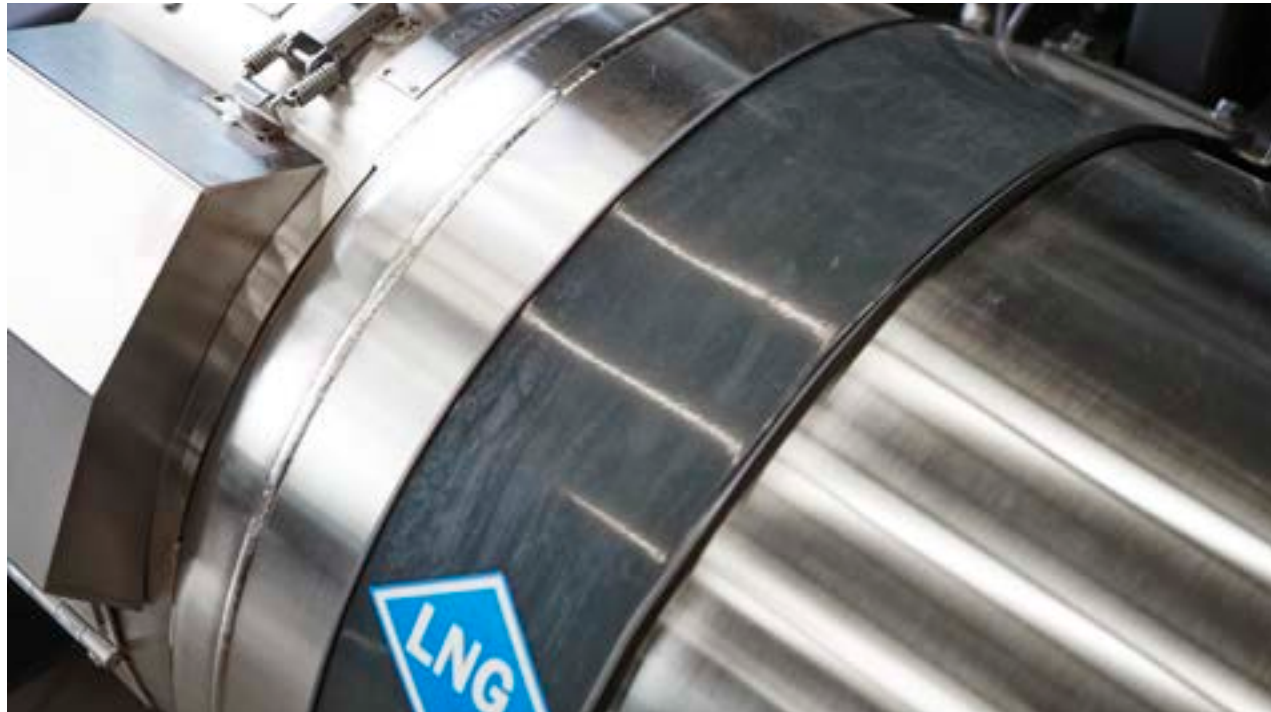
Retainer Brackets and Bands for LNG Tank

LNG tank must be returned in proper conditions as illustrated in picture.

Check that the brackets and the bands are present and properly tighten.

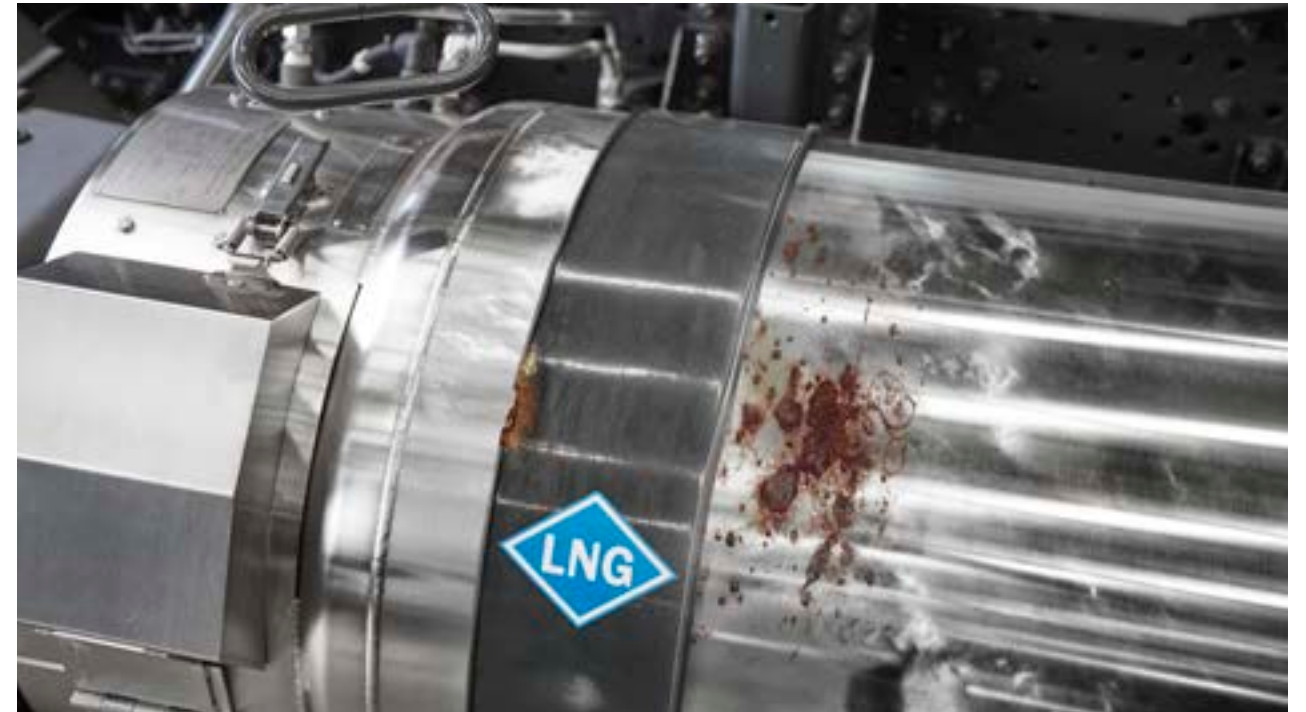
Rust, dents, breakages and/or gouges → charge for replacement of brackets and bands.

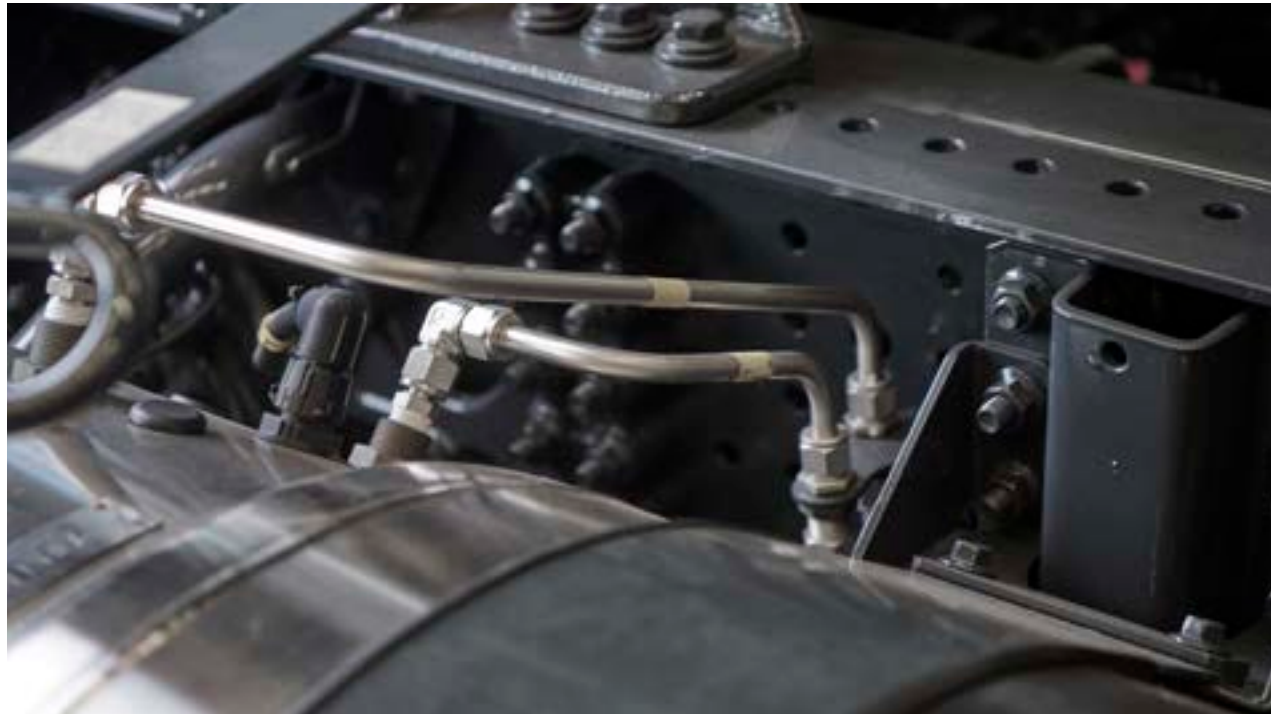
Rigid Lines for LNG Tank

LNG tank must be returned in proper conditions as illustrated in picture.

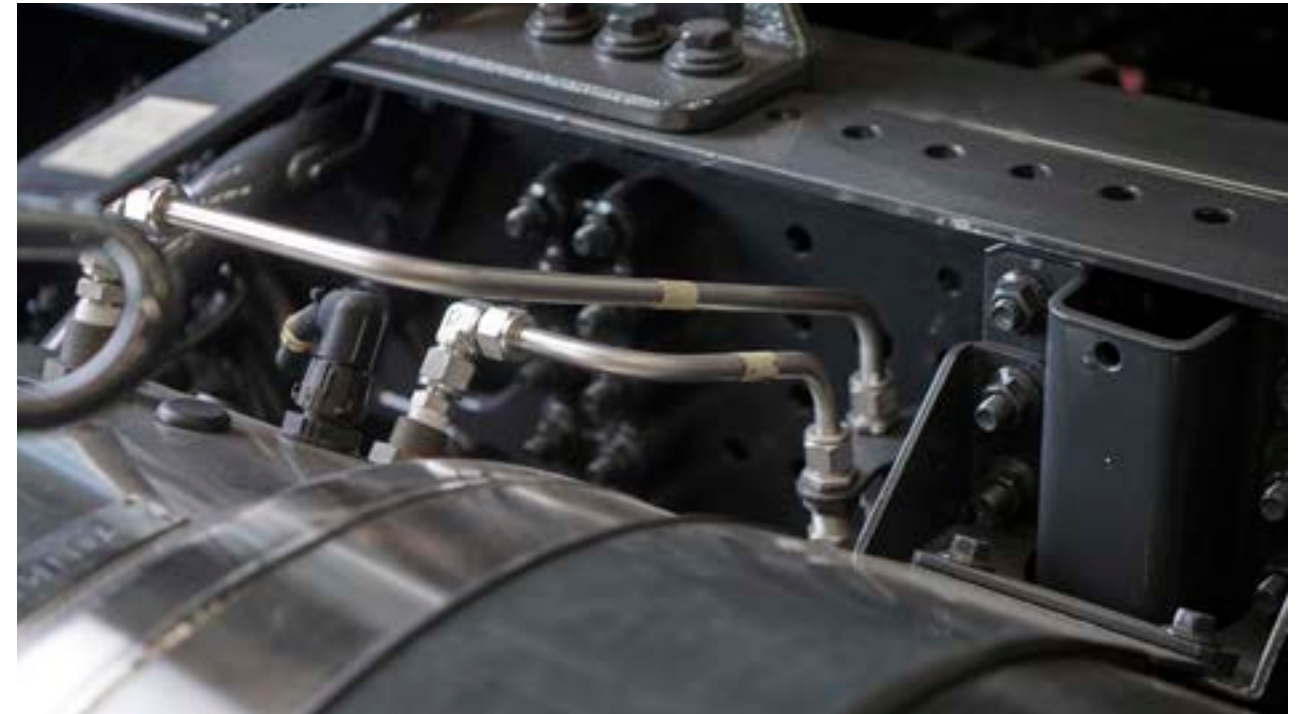
Rust, dents, breakages and/or gouges → charge for replacement of rigid lines.

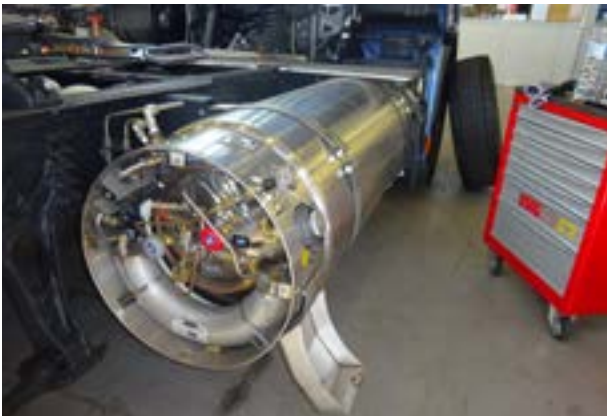
Important note: The maintenance plan calls for the mandatory replacement of the primary and secondary relief valves of any LNG tank by the fifth year after manufacture; in case the vehicle is returned after 5 years or more from the contract start date, the customer must ensure that the primary and secondary relief valves has been replaced before returning the vehicle to IVECO.

Inspect for presence of the red cap on the secondary relief valve → charge for replacement of the primary relief valve.

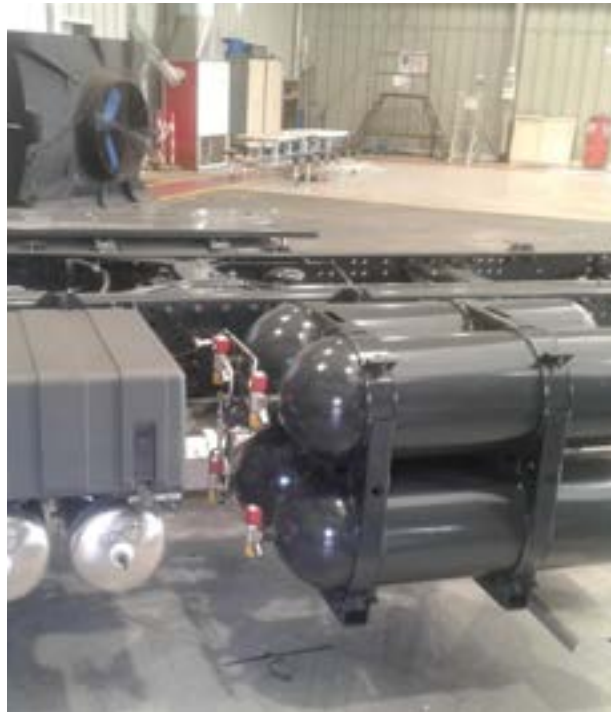
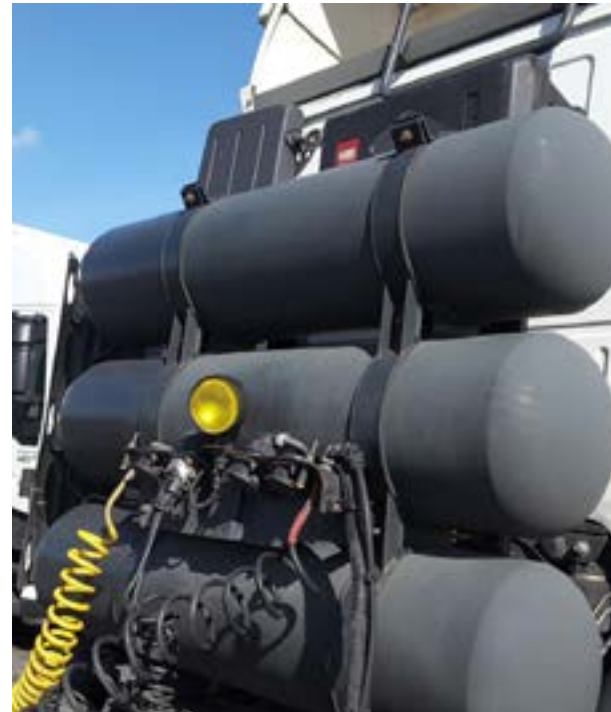
CNG Cylinders

CNG cylinders must be returned in proper conditions as illustrated in pictures.

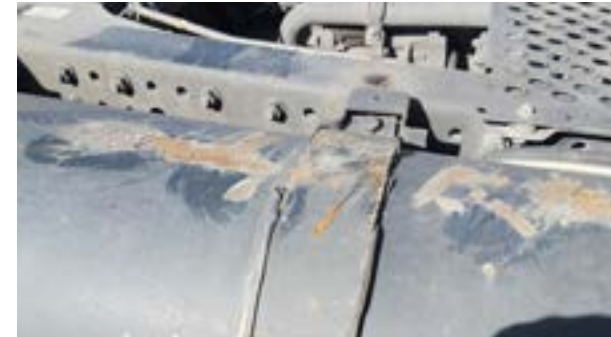
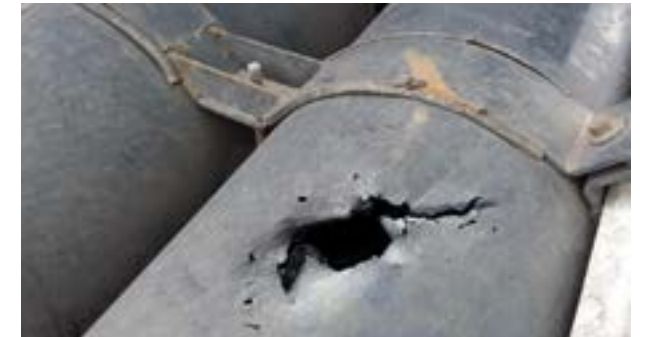
Evidence of repairs to the CNG cylinder → charge for replacement for CNG cylinder.

Holes in the CNG cylinder → charge for replacement for CNG cylinder.

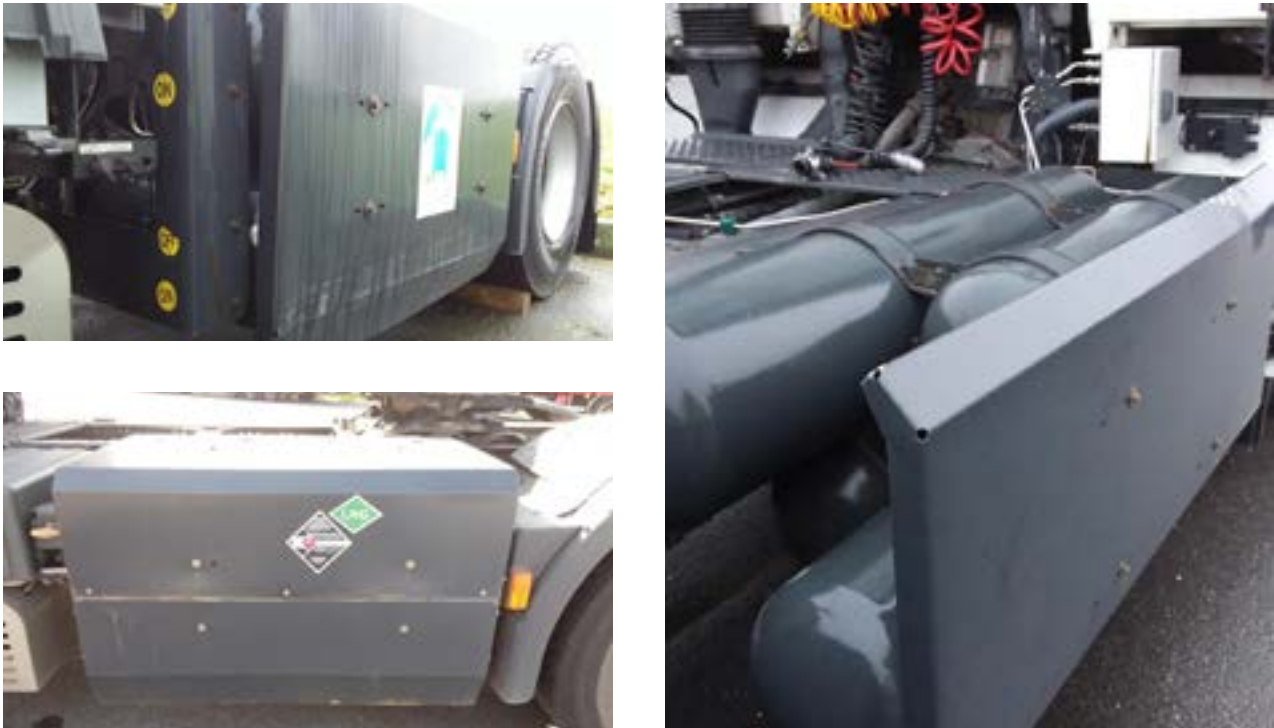
CNG Cylinders Protective Cover

CNG cylinders must be returned in proper conditions as illustrated in pictures.
Dents, deformations, rust and/or gouges that do not affect functionality and safety are accepted.

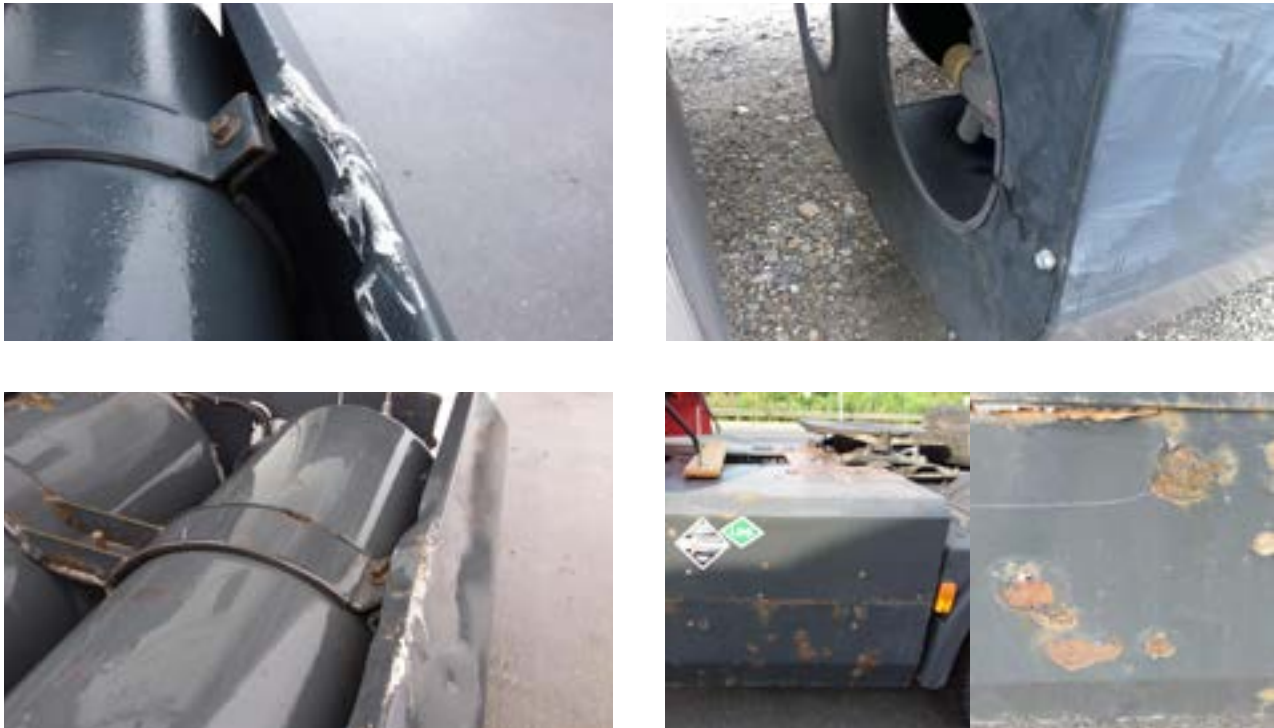
Visible dents and deformations that affect the functionality and/or safety
→ charge for replacement of protective covers.
Rust, breakages and/or gouges that affect the functionality and/or safety
→ charge for replacement of protective covers.
Where the covers are absent → charge for the replacement of these.

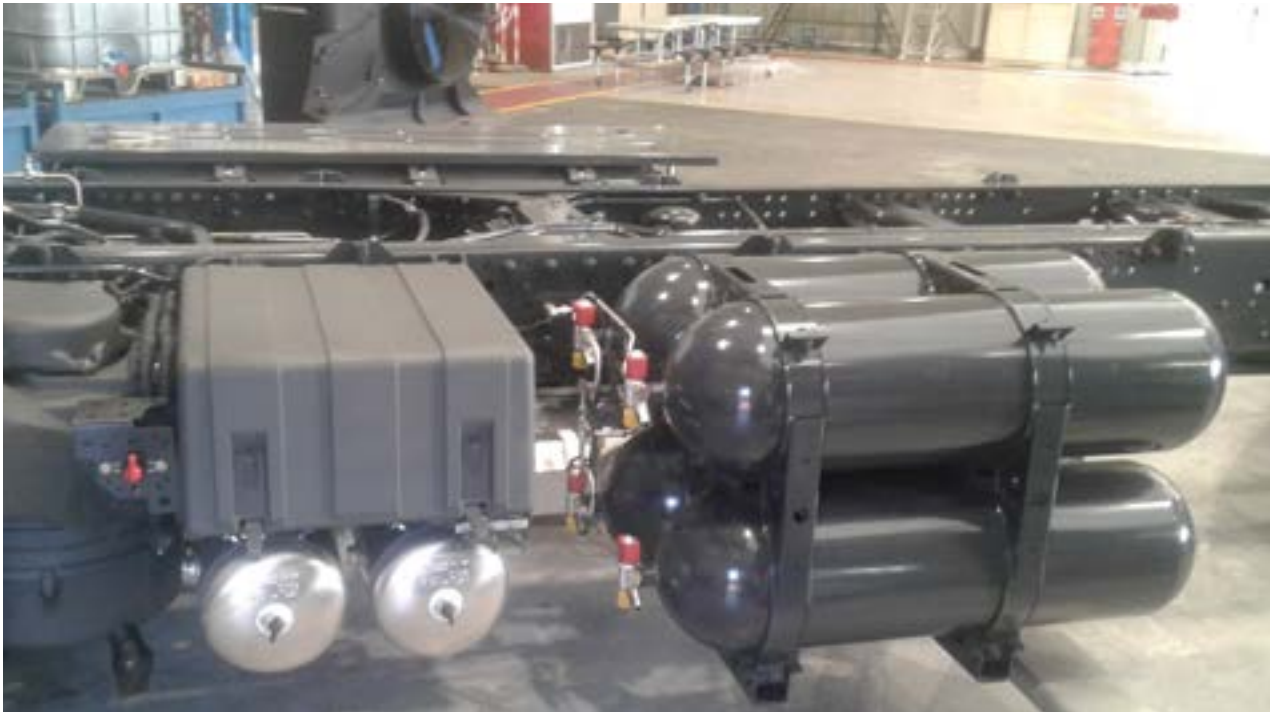
Retainer Brackets and Bands for CNG Cylinders

CNG cylinders must be returned in proper conditions as illustrated in picture.
Check that the brackets are present and properly tighten.

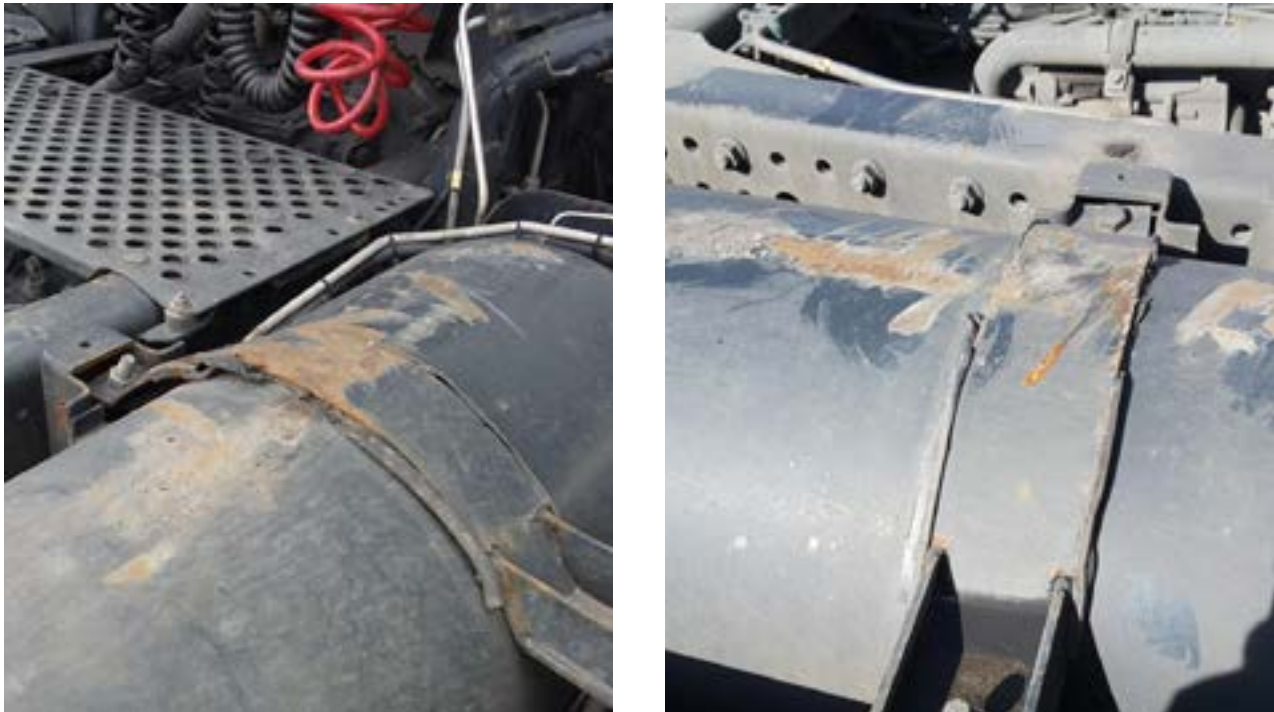
Rust, dents, breakages and/or gouges → charge for replacement of brackets and bands.

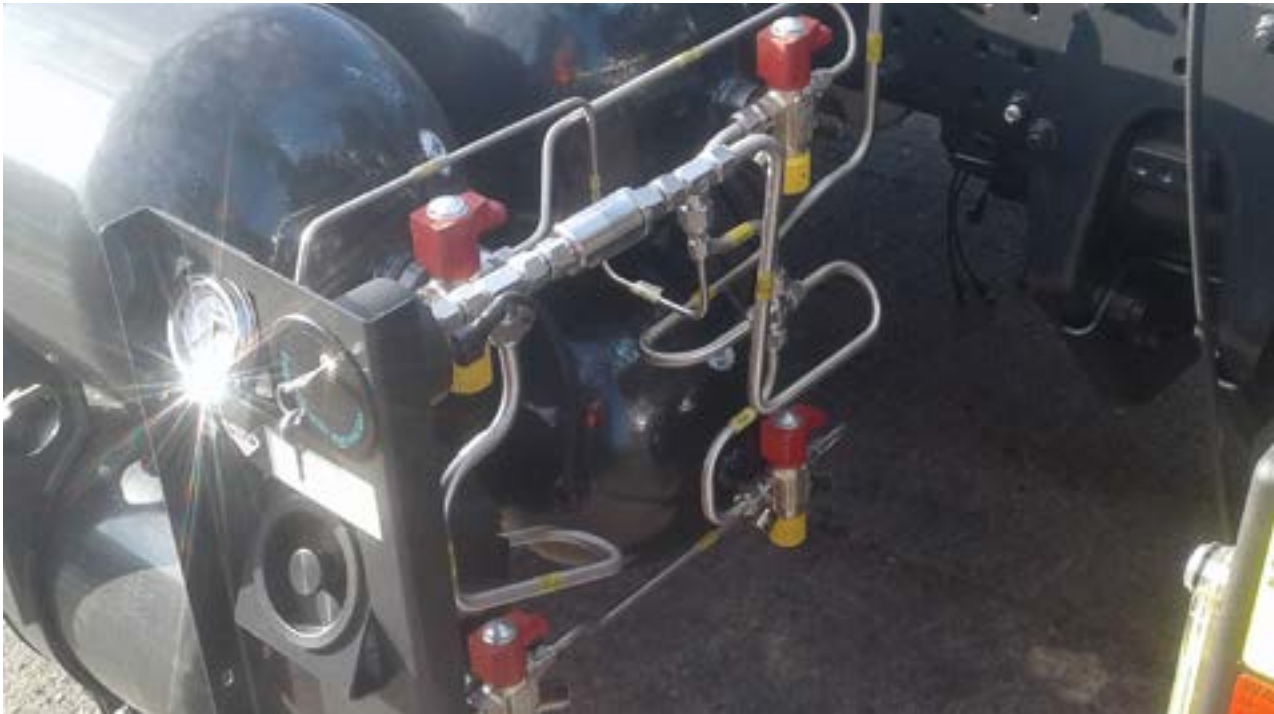
Rigid Lines for CNG Cylinders

CNG cylinders must be returned in proper conditions as illustrated in picture.

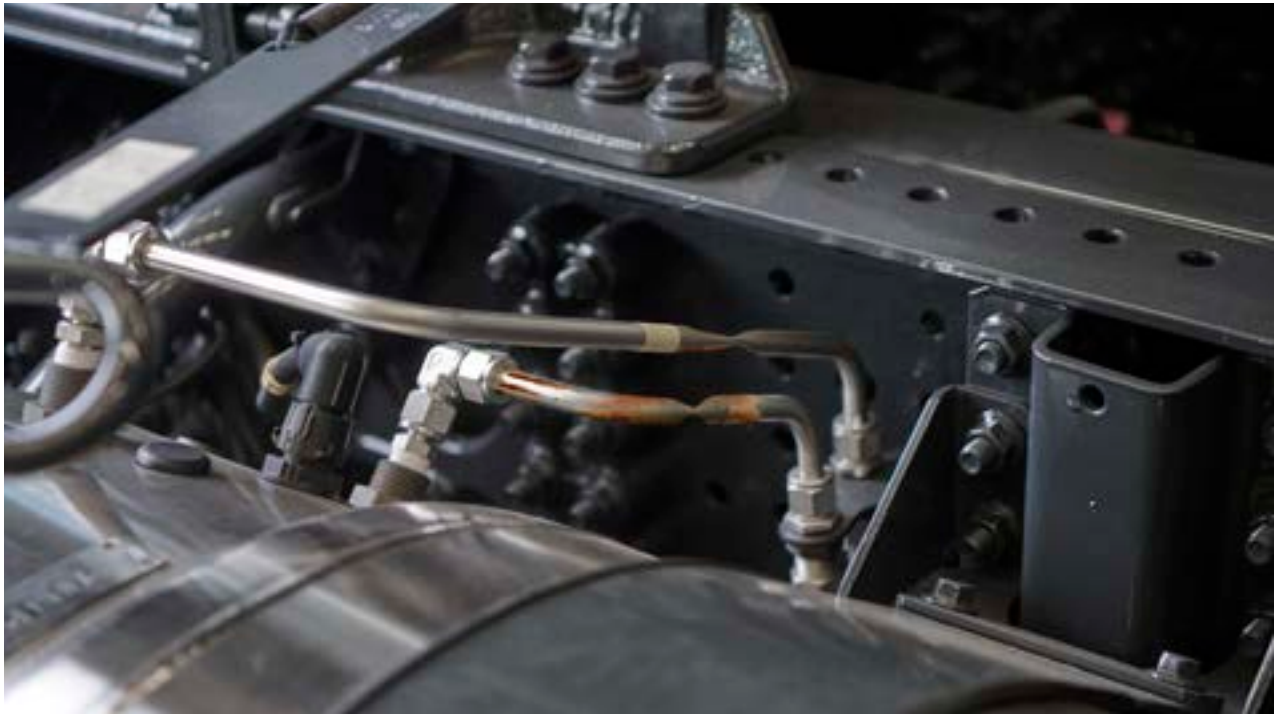
Rust, dents, breakages and/or gouges → charge for replacement of rigid lines.

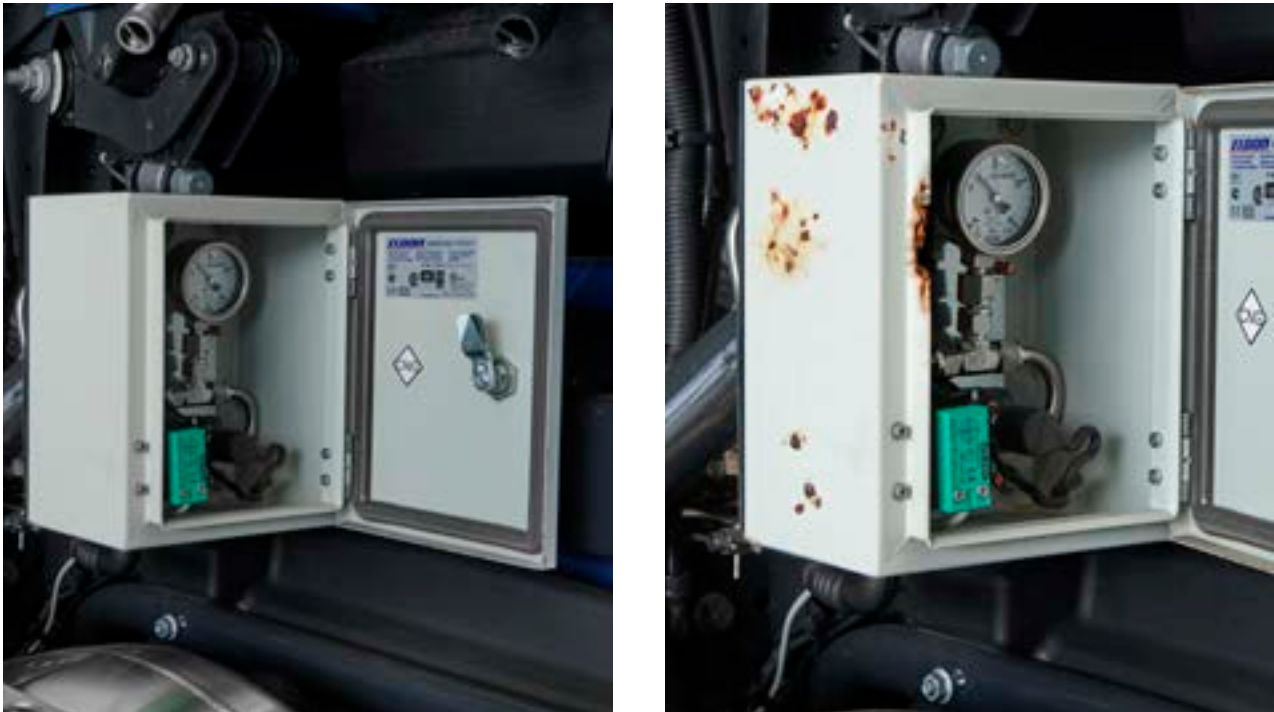
CNG Fill Receptacle Protection Box

Rust on the fill receptacle protection box → note without charge for damage.

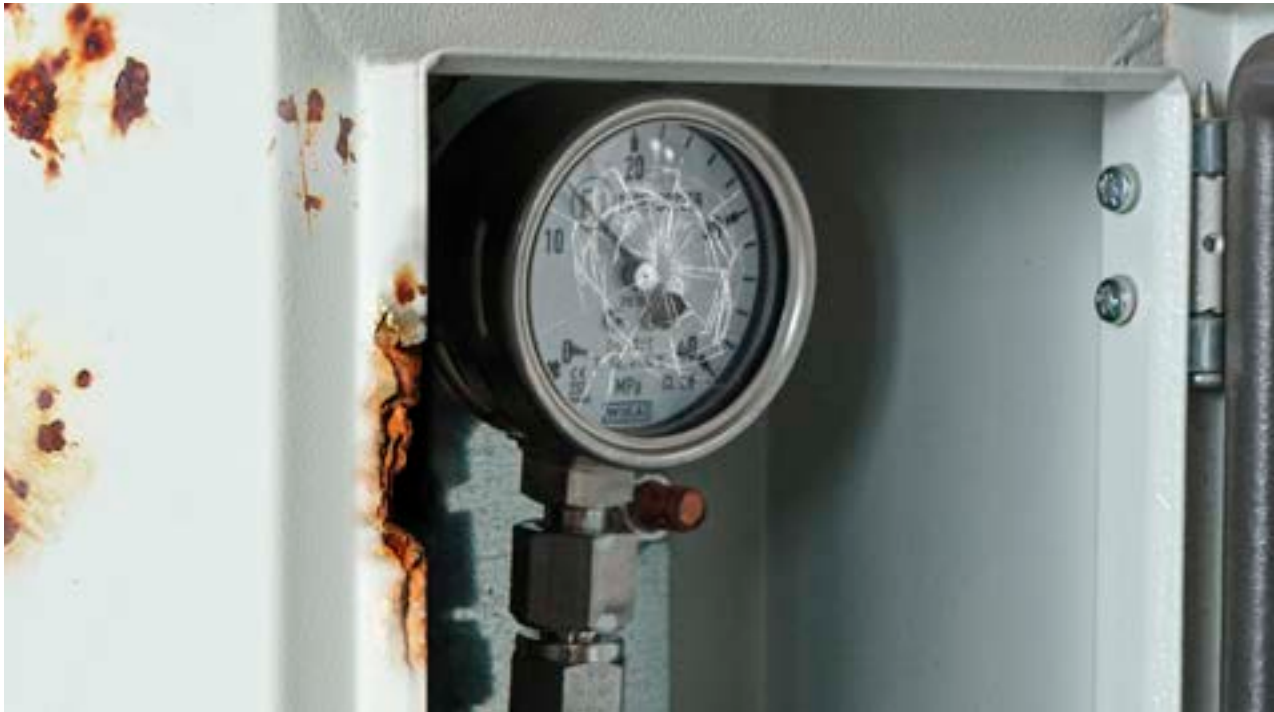
Missing protection box key, damaged CNG receptacle or pressure gauge → charge for replacement of the full box.

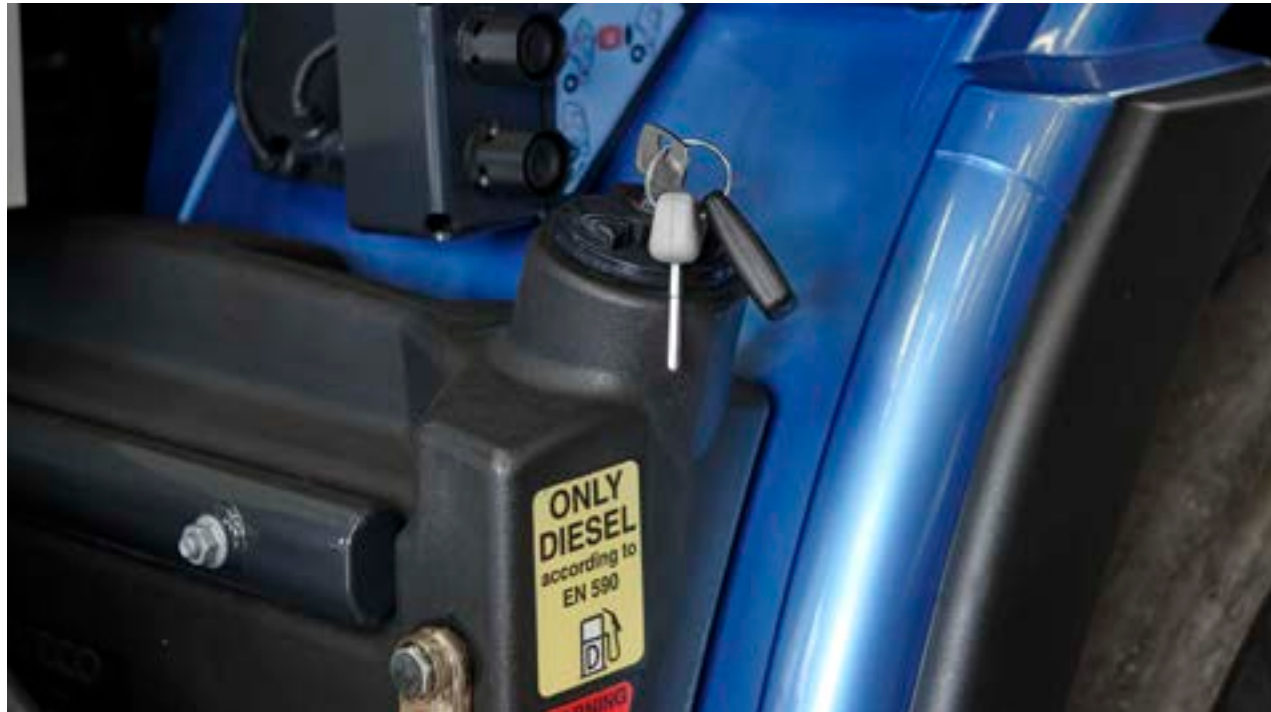
Inspection of Additional Heater Tank

Additional heater tank must be returned in proper conditions as illustrated in picture.

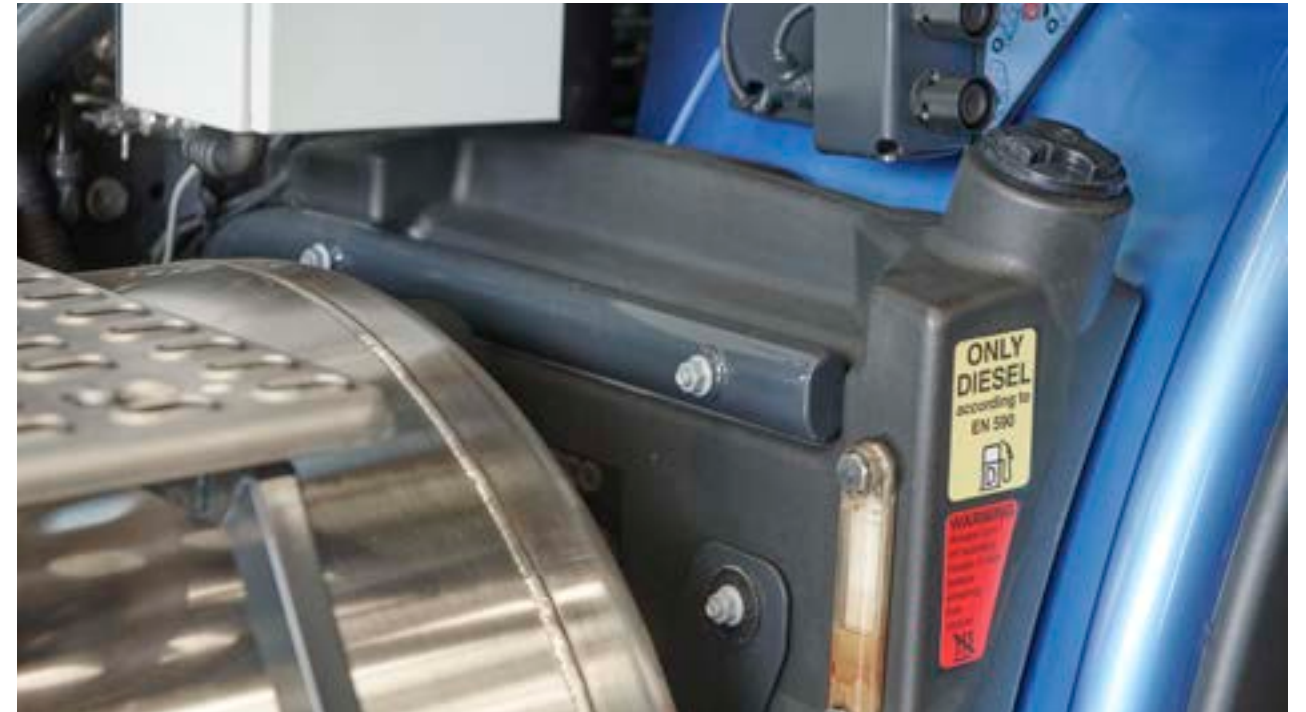
Missing additional heater tank key → charge for replacement of key.

Breakages on the additional heater tank → charge for replacement of the additional tank.

Level indicator shows water → charge for replacement of the additional heater tank.

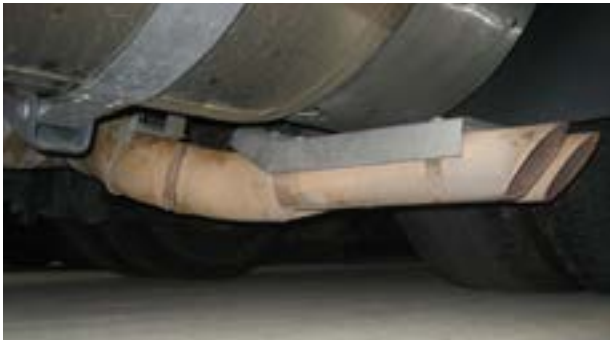
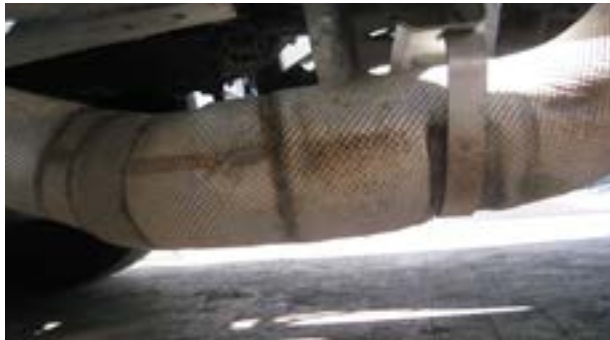
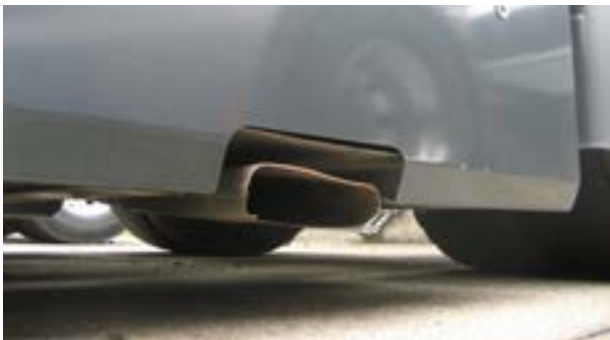
Exhaustsystem LNG/CNG

Normal use is accepted.

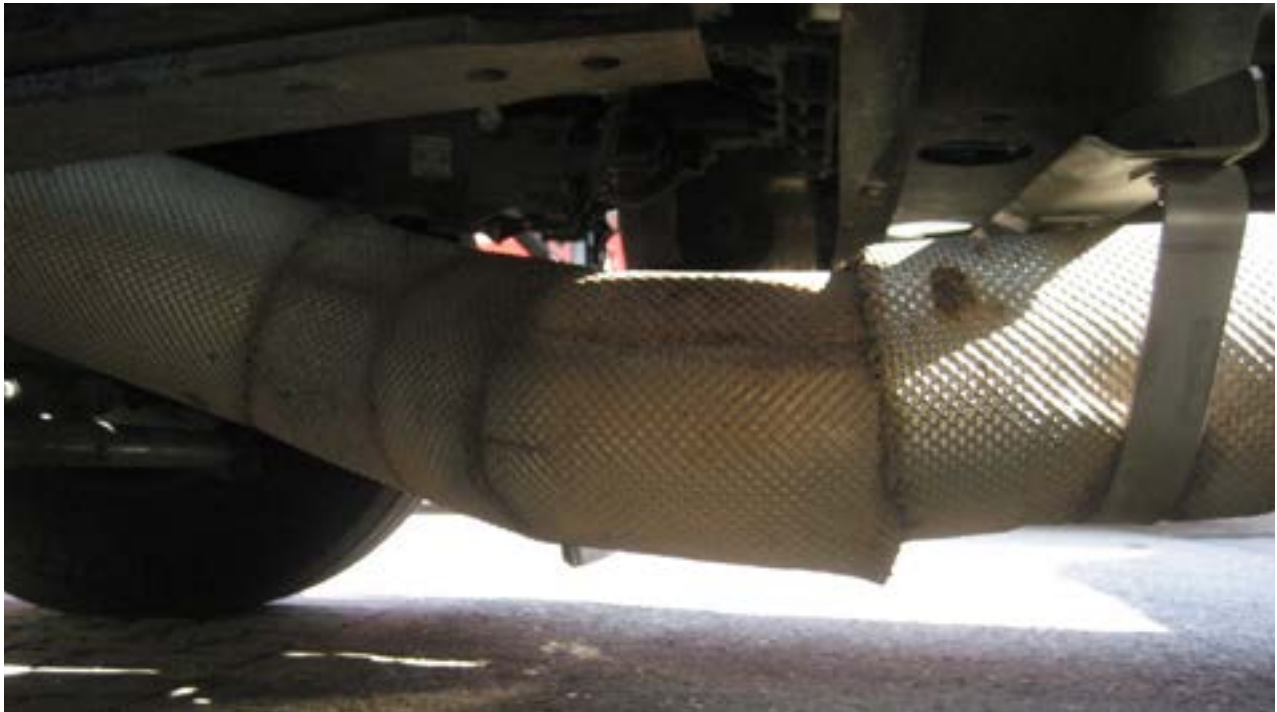
The following are not accepted: broken pipes, torn thermal insulation, scratches that are deep in the material, dents that reduce the pipe diameter.
